EXTRACT FROM THE EUROPEAN DIRECTIVE 2009/18/EC

1 MARINE CASUALTY INFORMATION

Time and Date	9 December 2019
Location	River Scheldt, Deurganckdok, near quay 1702
Deceased	0
Type of accident	Allision with gantry crane with hull damage below the waterline, impairing seaworthiness

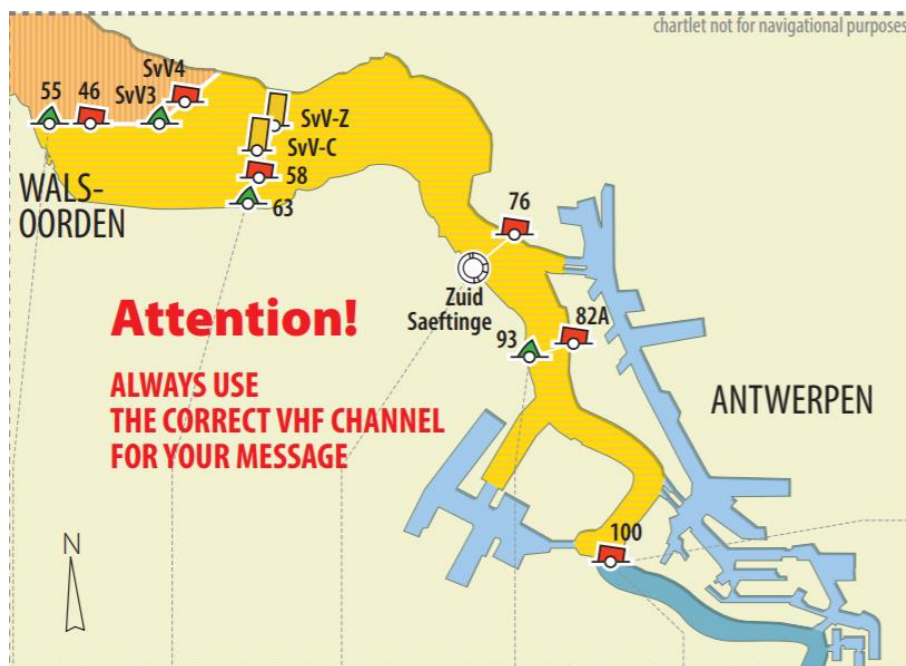
Figure 20 - VHF coverage near the Deurganckdok

From the website of the Common Nautical Management, www.vts-scheldt.net, we learned that there is a caution for the usage of the correct VHF channel. The VHF channels are defined as follows:
