Report on the collision between
fv Z.575 – HEIN SENIOR and mv ACEROMAR
on August 3rd 2020

in the traffic separation scheme Terschelling - German Bight
near Schiermonnikoog
with material and structural damage to the vessels.

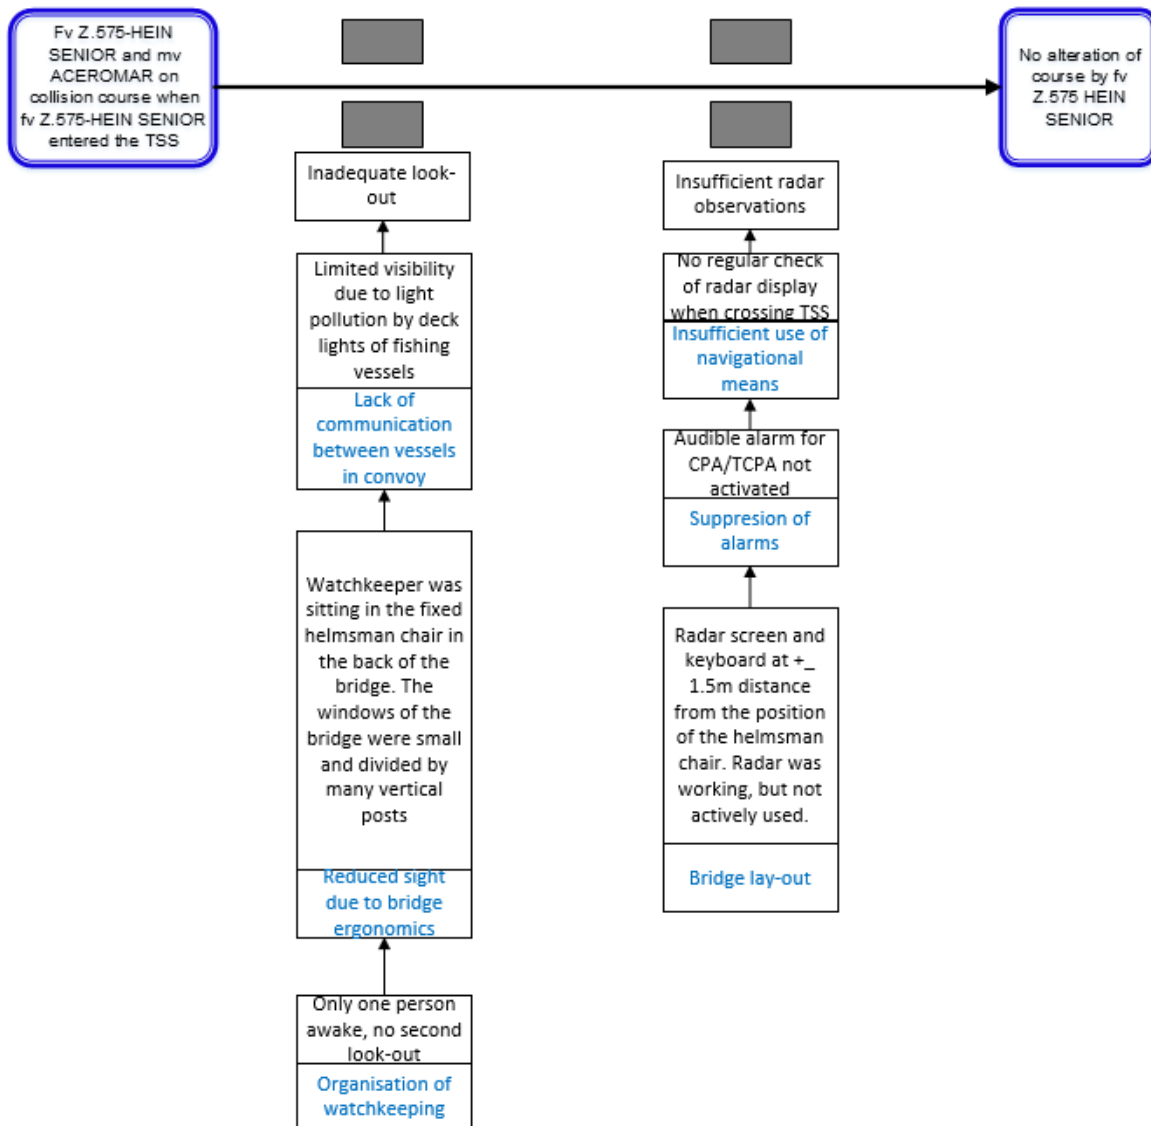
No alteration of course made by fv Z.575 HEIN SENIOR

Incident Barrier Failed	Performance / RC categories	Barrier Challenge / Causes	Remarks regarding performance
Inadequate Lookout	BFA Primary Causes	Lack of communication between vessels in convoy	Limited visibility due to light pollution by deck lights of fishing vessels
	BFA Secondary Causes	Reduced sight due to wheelhouse ergonomics.	Watchkeeper was sitting in the fixed helmsman chair in the back of the wheelhouse. The windows of the wheelhouse were small, divided by many vertical posts.
	BFA Tertiary Causes	Organisation of watchkeeping	Only one person awake, no second lookout
Incident Barrier Failed	Performance / RC categories	Barrier Challenge / Causes	Remarks regarding performance
Insufficient radar observations	BFA Primary Causes	Insufficient use of navigational means	No regular check of radar screen when crossing TSS
	BFA Secondary Causes	Suppression of alarms	Audible alarms for CPA/TCPA not activated

BFA Tertiary Causes	Wheelhouse lay-out	Radar screen and keyboard at +-1.5m distance from position of chair where lookout was sitting. Radar was working, but not actively used

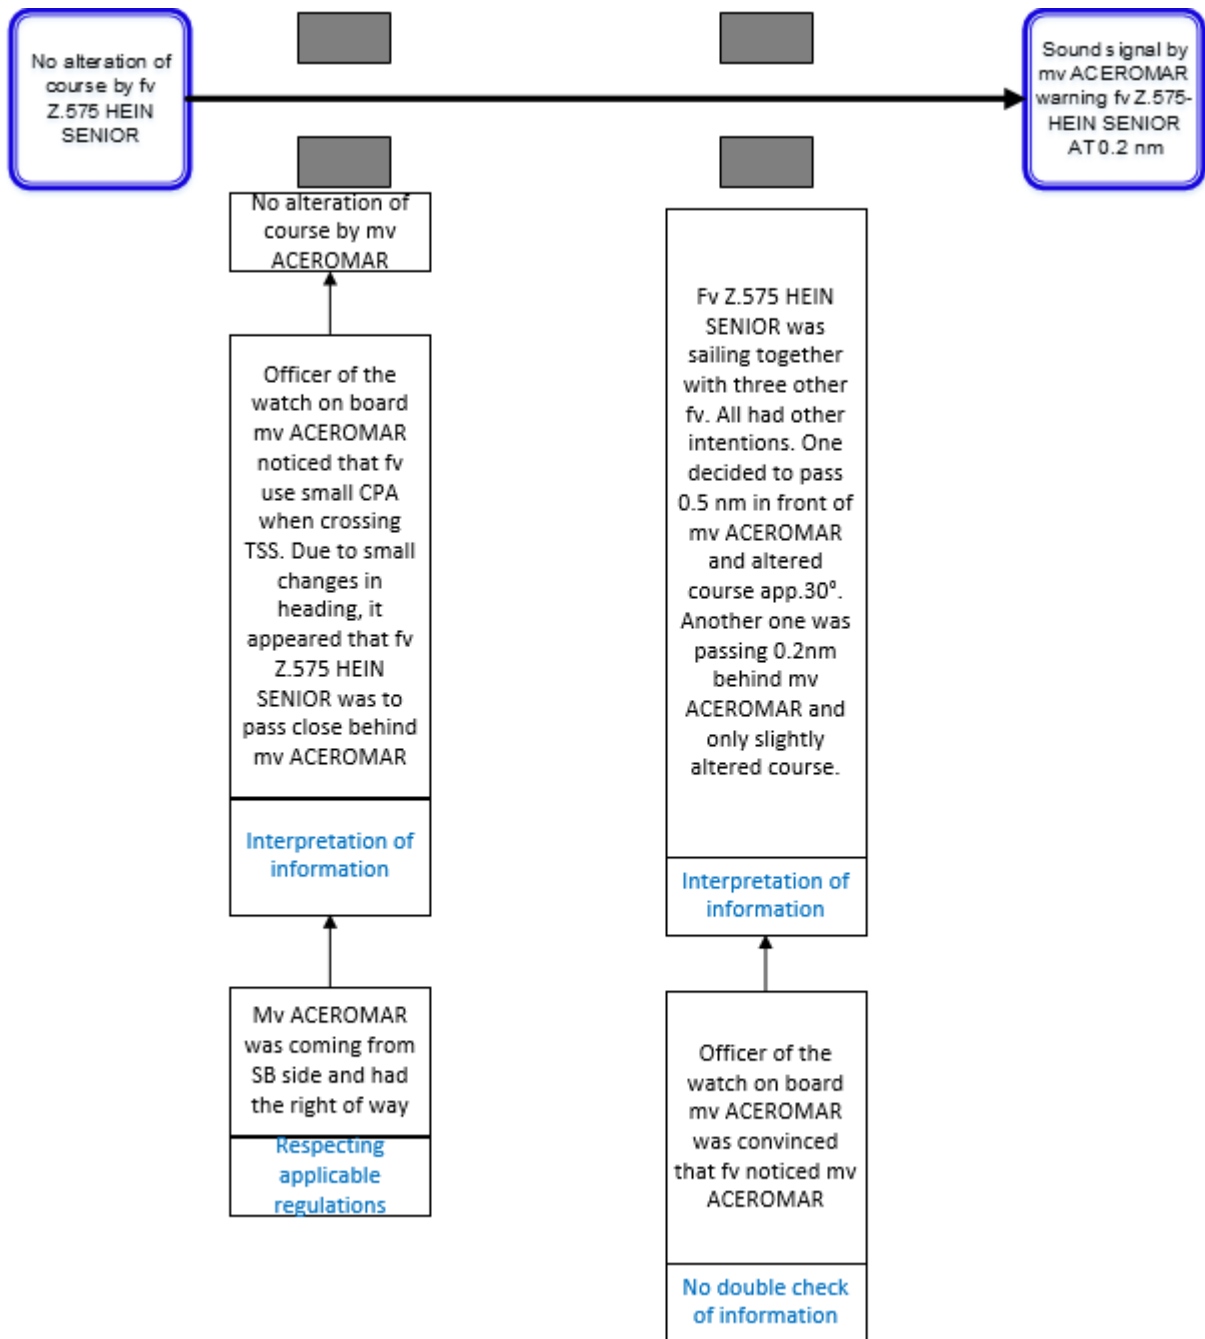
Sound signal by mv ACEROMAR to warn fv Z.575 HEIN SENIOR at 0.2nm

Incident Barrier Failed	Performance / RC categories	Barrier Challenge / Causes	Remarks regarding performance
No alteration of course made by mv ACEROMAR	BFA Primary Causes	Interpretation of information	Officer of the watch noticed that fishing vessels apply small CPA when crossing vessels. Due to small changes in heading, it looked like fv Z.575 HEIN SENIOR was to pass at close CPA behind mv ACEROMAR
	BFA Secondary Causes	Regulations do not encourage to initiate action	mv ACEROMAR was coming from SB side and had right of way, so watchkeeper had not the intention to take action early
Incident Barrier Failed	Performance / RC categories	Barrier Challenge / Causes	Remarks regarding performance
No VHF communication	BFA Primary Causes	Interpretation of information	Fv Z.575-HEIN SENIOR was sailing with 3 other fishing vessels, all had other intentions; One decided to cross 0,5 nm in front of mv ACEROMAR and made a wide alteration in course (>30°), another one was passing at 0.2nm behind mv ACEROMAR and made a small alteration in course (< 10°).

BFA Secondary Causes	No double check of information	Officer of the watch on board mv ACEROMAR was convinced that fishing vessels noticed mv ACEROMAR

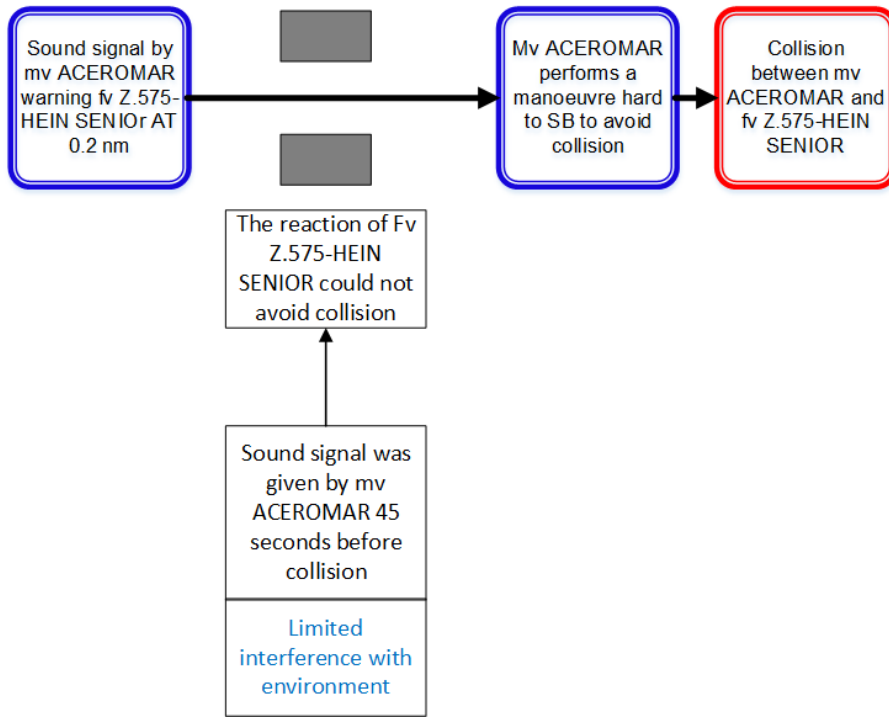
mv ACEROMAR makes an emergency manoeuvre, hard to SB to avoid collision

Incident Barrier Unreliable	Performance / RC categories	Barrier Challenge / Causes	Remarks regarding performance
The reaction of Fv. Z.575-HEIN SENIOR could not avoid collision	BFA Primary Causes	Limited interference with environment	Sound signal was given 45 sec before collision

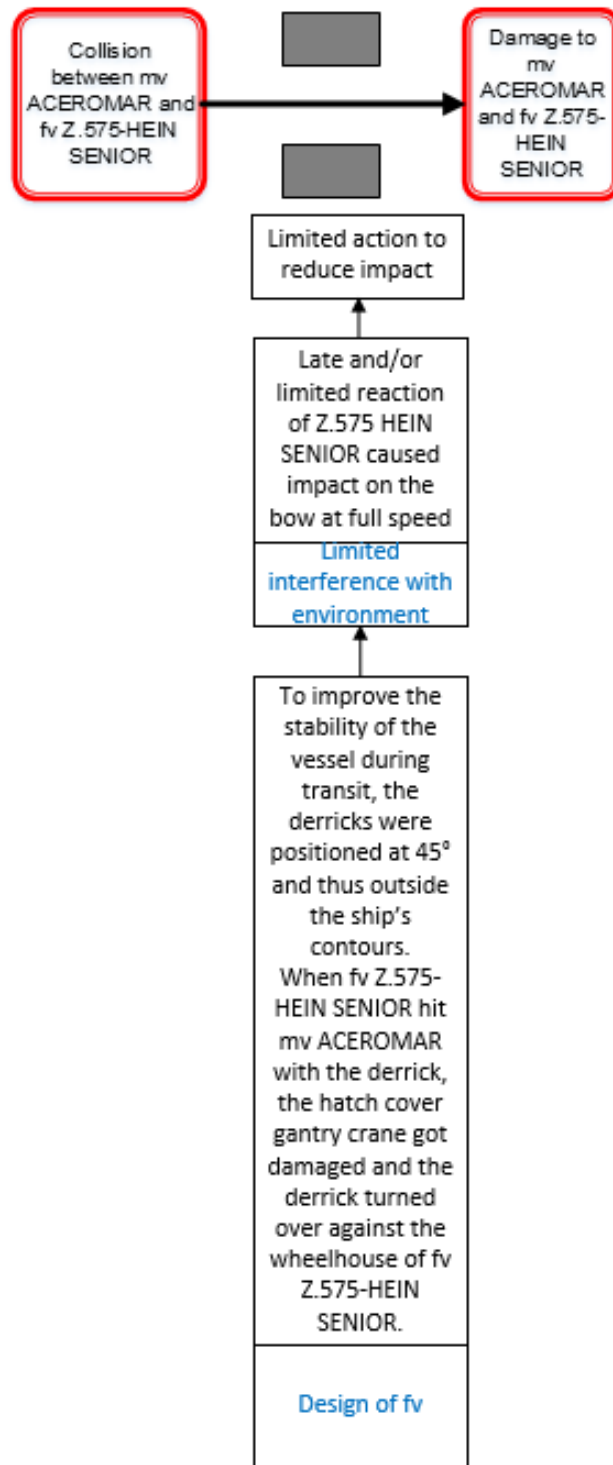
Sound signal by mv ACEROMAR to warn fv Z.575 HEIN SENIOR at 0.2nm

Incident Barrier Failed	Performance / RC categories	Barrier Challenge / Causes	Remarks regarding performance
	BFA Primary Causes	Limited interference with environment	Late and/or limited reaction of fv Z.575 HEIN SENIOR caused impact on the bow at full speed
Limited action to reduce impact	BFA Secondary Causes	Design of vessel	To improve the stability of fv Z.575-HEIN SENIOR during sailing, derricks were placed at 45° and outside ship's contours. When fv Z.575-HEIN SENIOR hit mv ACEROMAR with the derrick, the hatch cover gantry crane got damaged and the derrick turned over against the wheelhouse of fv Z.575 HEIN SENIOR.

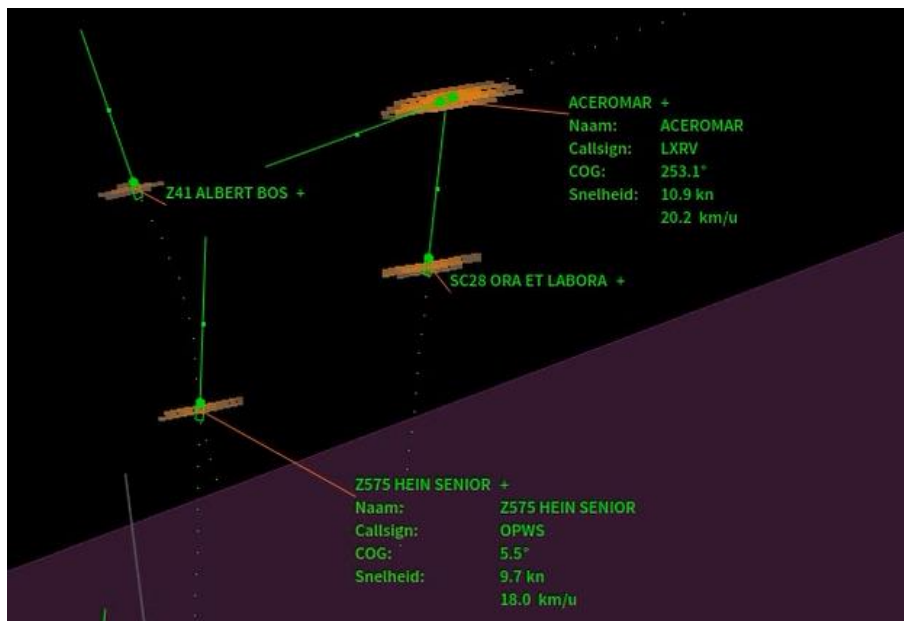
Figure 24 – Radar positions at 03:59 hours

Figure 24 shows the traffic situation at 03:59 hours. At that moment, there is a difference in bearing of approximately 030° between both fishing vessels.

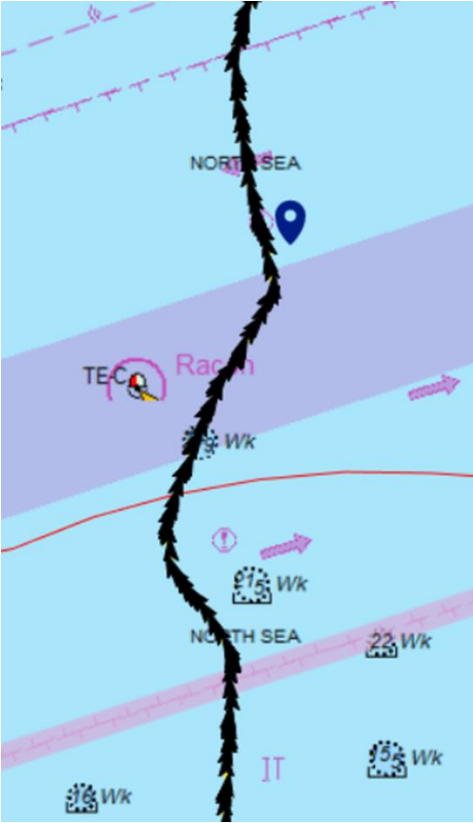
Figure 27 - Track of fv Z.41-ALBERT BOS

Figure 27 shows how fv Z.41-ALBERT BOS clearly showed her intentions by altering course.

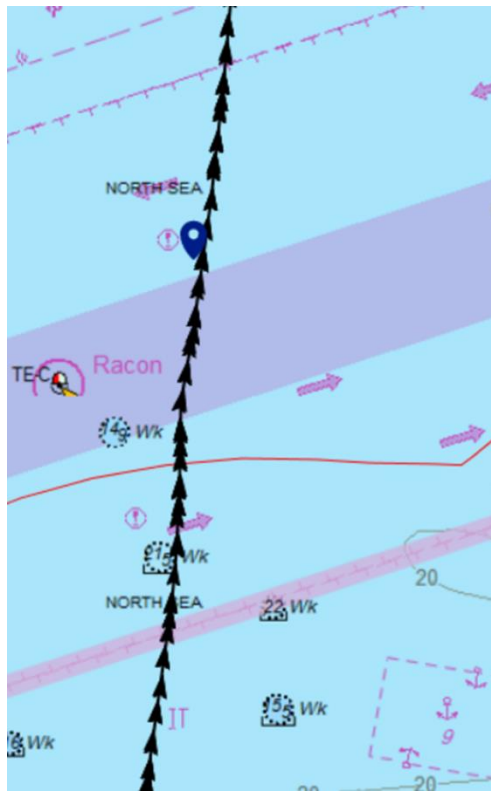
Figure 28 - Track of fv SC.28-ORA ET LABORA

Figure 28 shows the small course alterations made by fv SC.28-ORA ET LABORA and Figure 29 shows the track of fv Z.575-HEIN SENIOR.

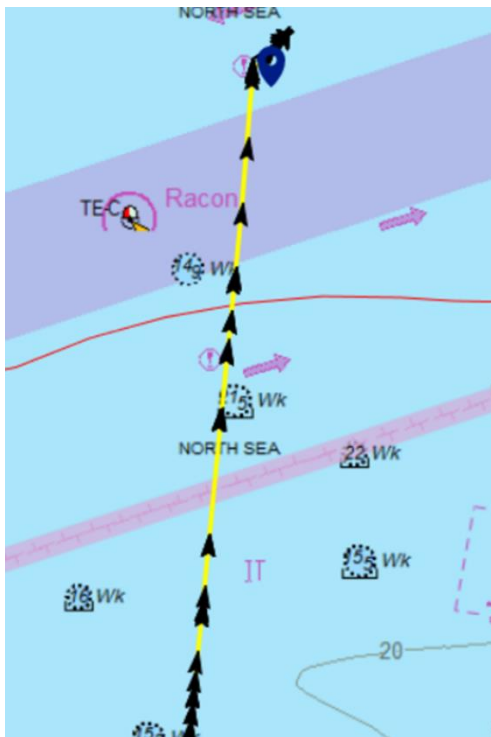
Figure 29 - Track of fv Z.575-HEIN SENIOR

The track of fv Z.575 HEIN SENIOR was straight , since she did not alter course during the passage of the TSS.
