Report on the grounding of
fv Z.575 – HEIN SENIOR
on October 12th, 2020

off the isle of Vlieland,
with damage to the propeller.

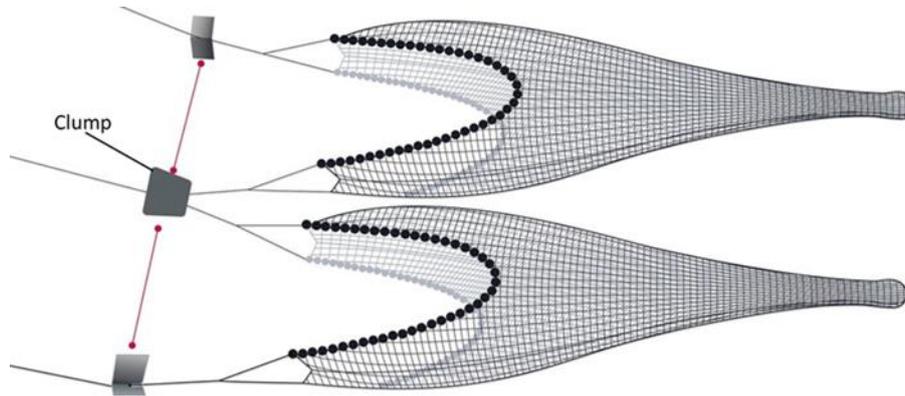
Figure 3 –Example of a clump

Fv Z.575-HEIN SENIOR tried to slow down the drifting speed by dropping the clump, see Figure 3.²

² The clump or centre weight is a part of the fishing gear that connects two warps in a twin rig configuration. The clump is positioned at the stern.
