Report on the investigation
into a collision between
fv Z.18 – SOETKIN and mv CALYPSO.GR
on February 12th 2021

in the English Channel
with serious damage to the fishing vessel.

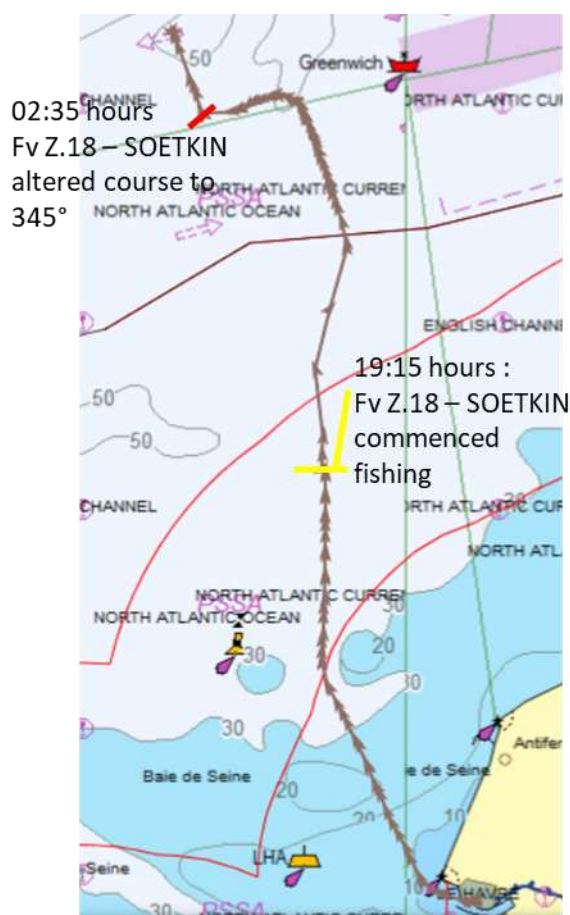
Figure 1 - Track of fv Z.18 – SOETKIN

On Friday February 11th 2021, the fv Z.18 - SOETKIN had left the port of Le Havre around 16:00 hours, aiming for fishing grounds in the English Channel. Later that day, around 19:15 hours, fv Z.18 – SOETKIN had started fishing SSW of Greenwich light vessel, as shown in Figure 1.

Around 02:35 hours, W of Greenwich Light Vessel, the fv Z.18-SOETKIN altered course, to continue fishing on a course of 345°, as seen in Figure 1.

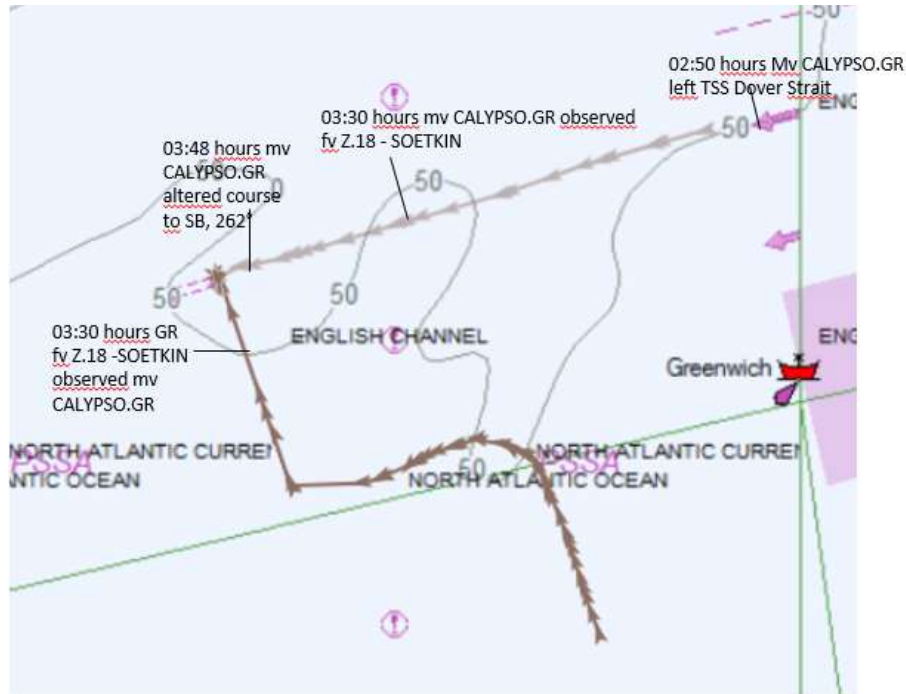
Figure 2 - Mv CALYPSO.GR leaving Dover Strait TSS

On February 7th 2021, the mv CALYPSO.GR had left the port of Riga, Latvia, bound for the port of Manzanillo, Mexico. On February 12th, around 02:50 hours, the mv CALYPSO.GR left Dover Strait TSS, sailing on a course of 254°, as indicated in Figure 2. Her speed was approximately 13,5 knots.

Figure 2 shows the positions of both vessels when they sighted each other.

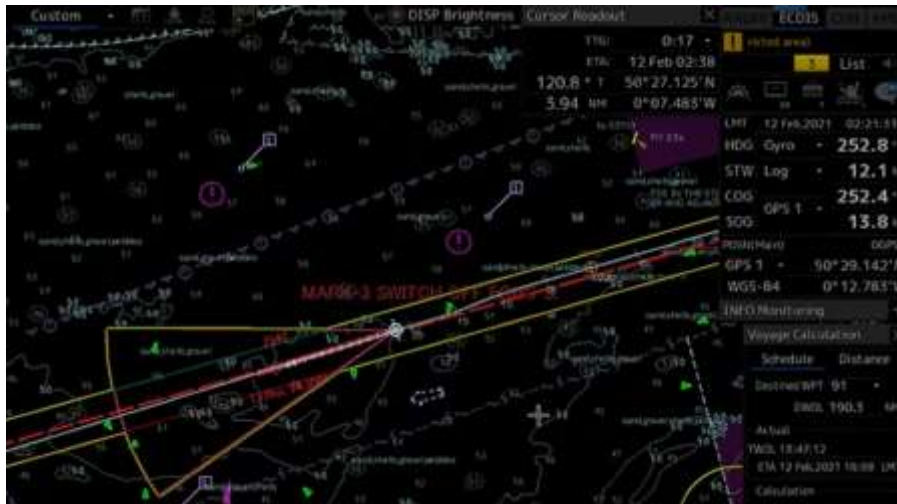
Figure 3 - ECDIS as used on board mv CALYPSO.GR

The mv CALYPSO.GR was equipped with an ECDIS system that was actively used during the sea passage. Figure 3 shows how a look ahead function or anti-grounding cone was set in front of the vessel to warn in case of shallows and how cross track distance lines were set to mark the vessel's safety corridor.

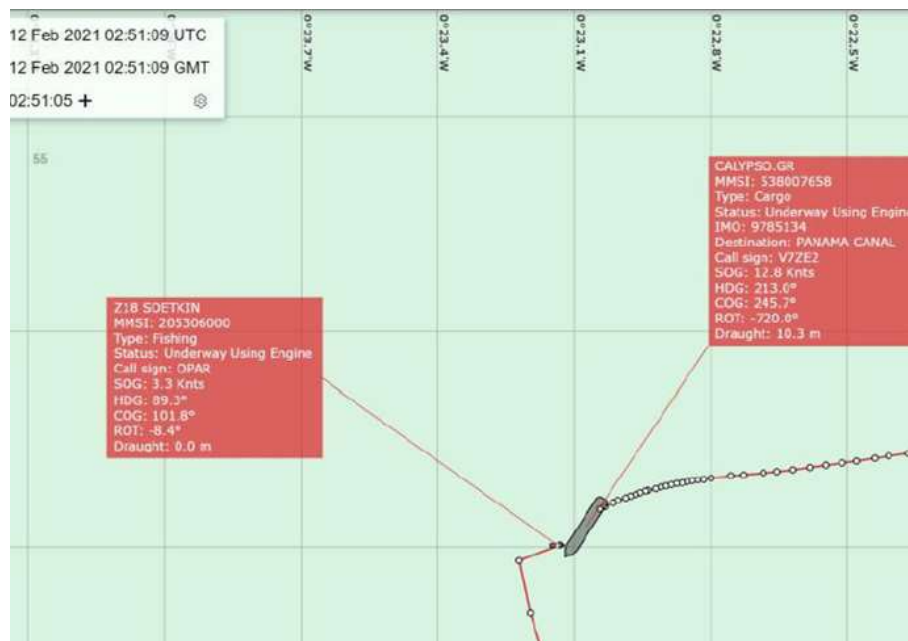
Figure 4 - Manoeuvres based on AIS data

Seconds later, both vessels collided. The SB bow of the mv CALYPSO.GR collided with the PS bow of the fv Z.18 – SOETKIN. At the time of impact, the mv CALYPSO GR was on a heading of 220° and the fv Z.18 – SOETKIN was on a heading of 104°. Figure 4 represents the situation when both vessels where manoeuvring, just before impact.

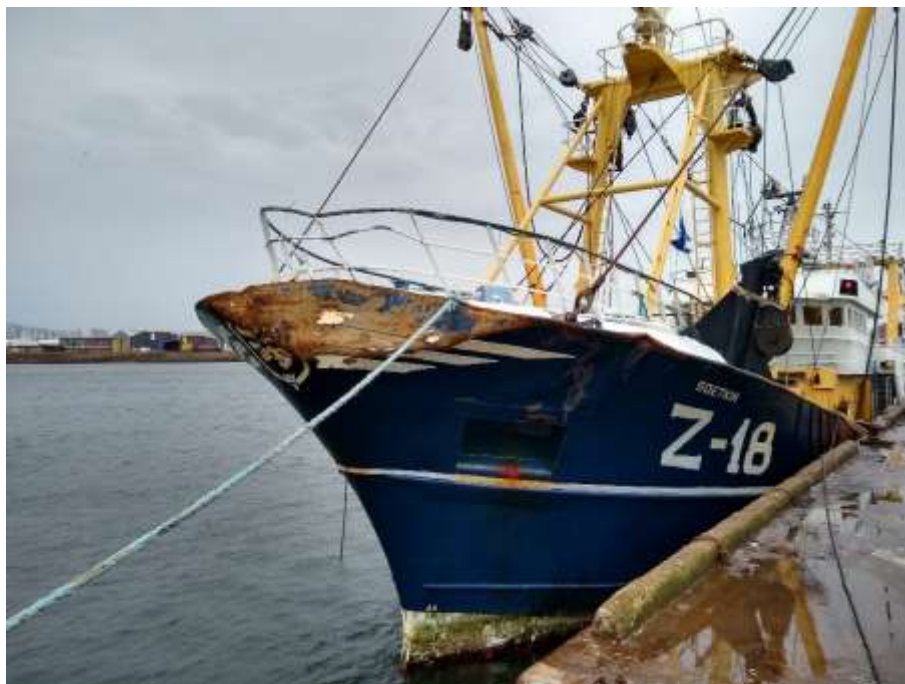
Figure 7 - Fv Z.18 - SOETKIN moored in Zeebrugge

The next day, February 13th 2021, around 05:00 hours, the fv Z.18 - SOETKIN arrived in Zeebrugge where it safely moored alongside as seen in

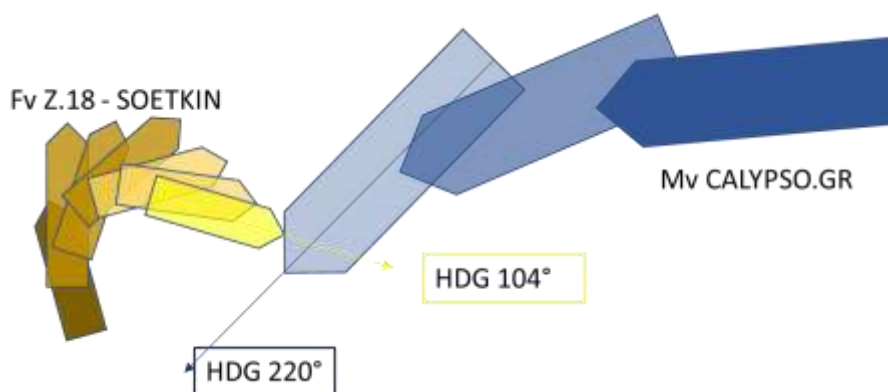
Figure 10 - Pictorial representation of the manoeuvres

The SB bow of the mv CALYPSO.GR first collided with the bow of the fv Z.18 – SOETKIN. At that moment, the heading of the mv CALYPSO.GR was approximately 220° and the heading of the fv Z.18 – SOETKIN was approximately 104°, as represented in Figure 10.

Exact headings at the moment of collision could not be determined since both vessels were still turning.

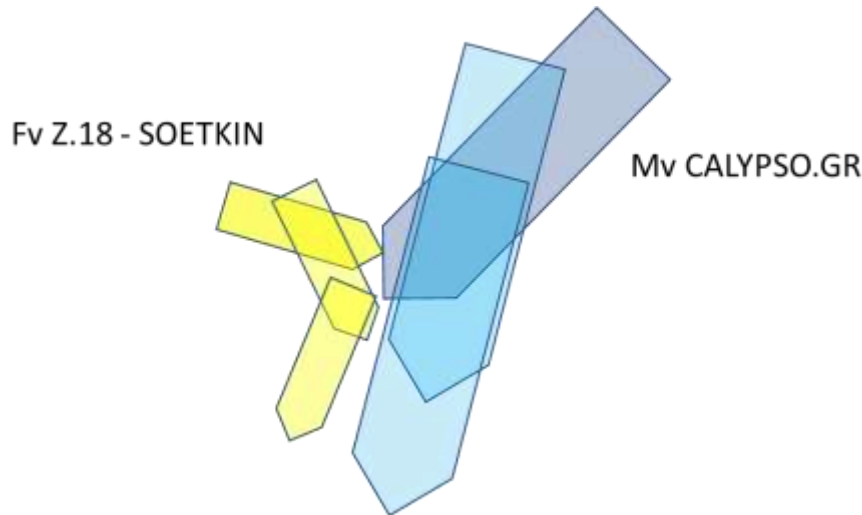
Figure 13 - Drawing of manoeuvres

Just behind the bow of both vessels, there was no damage. This indicated that the vessels came free off each other shortly after the first impact. This can be explained by the fact that both vessels were still turning, as shown in Figure 13.
