**Federal Bureau for the Investigation  
of Maritime Accidents**

2022/017548

Report on the investigation into the  
death of a crewmember on board  
the mts MAGNIFICA during  
manoeuvring in the ZANDVLIET  
lock at the  
Port of Antwerp on  
26th of July 2022

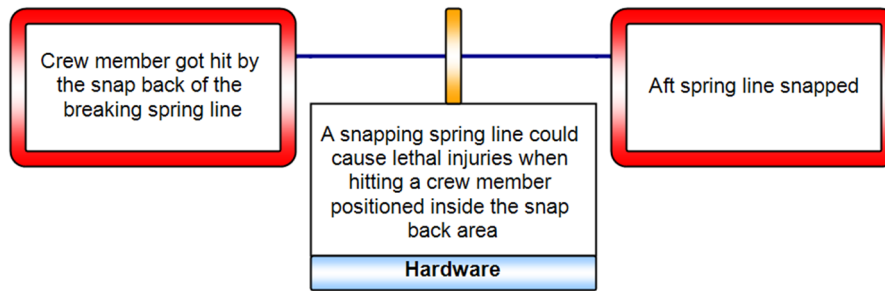
Incident Barrier	Performance / RC Categories	Barrier Challenge / Causes	Comments about performance
<b>Aft spring line snapped</b>			
A snapping spring line could cause lethal injuries when hitting a crew member positioned inside the snap back area	Unreliable

From: **Event Crew was instructed to make fast**

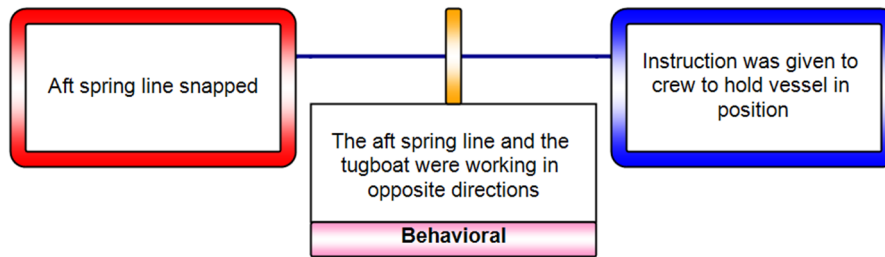
Incident Barrier	Performance / RC Categories	Barrier Challenge / Causes	Comments about performance
<b>Instruction was given to crew to hold vessel in position</b>			
The aft spring line and the tugboat were working in opposite directions	Unreliable

From: Threat Crew member positioned in vicinity of rear fairlead
