Preliminary Safety Investigation Report

Ref.:
AAIU-2026-02-05-01
Status:
Preliminary
Issue date:
06 March 2026

**SERIOUS INCIDENT
A320 NEO
AT BRUSSELS AIRPORT
ON 05 FEBRUARY 2026**

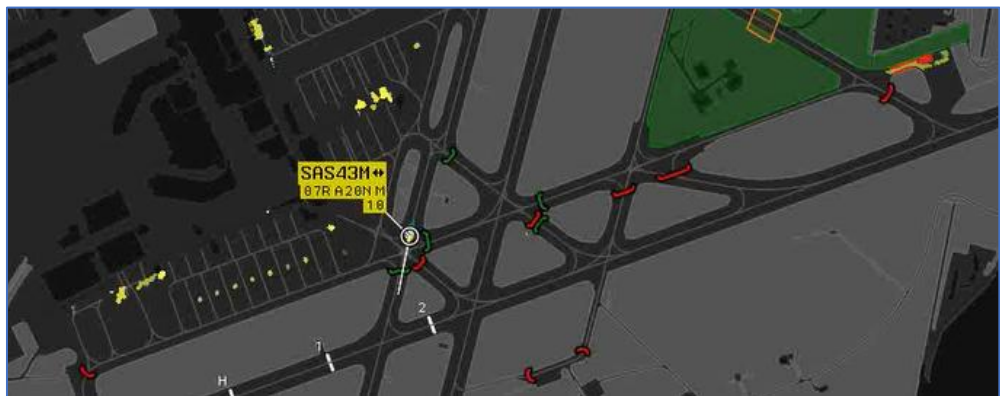
Figure 7 : extract of ground radar screen at take-off clearance. White vector is a representation of heading and groundspeed.

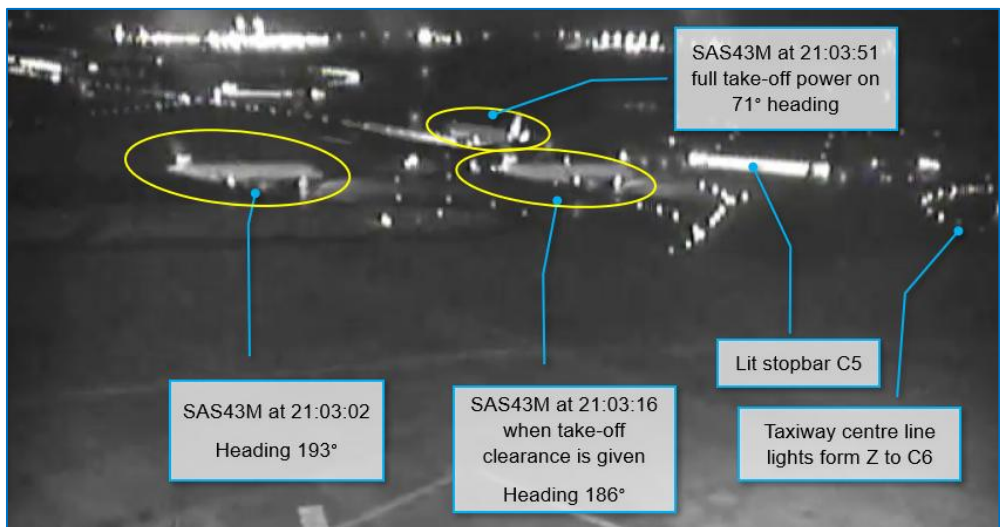
Figure 8 : composite image of CCTV recordings

At 21:03:40, the captain asked the first officer whether the crew was ready for take-off, and the first officer confirmed readiness. At that moment, the CCTV recording shows the landing light being switched on, while the aircraft was still rolling at a groundspeed of 3 knots and completing its alignment.

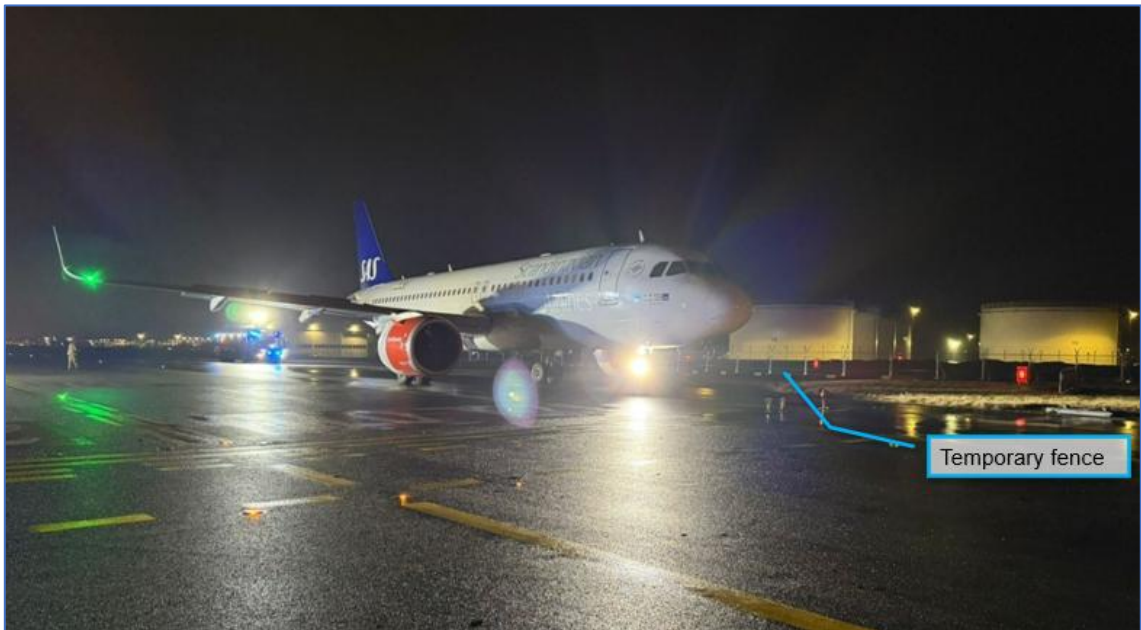
The initial intention of the flight crew was to taxi the aircraft back to the gate. However, following consultation between the crew, airport operations, and the ARFF, it was decided that the passengers would be disembarked on site and the aircraft would be towed. Although no impact had taken place, the nose landing gear was positioned immediately in front of the runway guard lights (wigwags) left of the stop bar at C1 (see also Figure 11), which required removal prior to towing.

Figure 12 : Frontal photo (source : Brussels Airport Company)

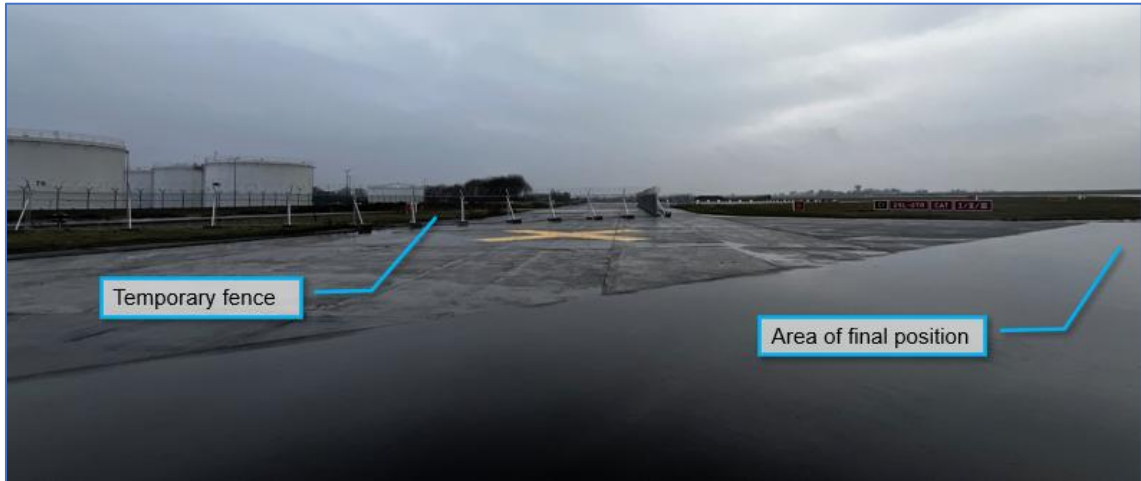
Figure 13 : View on P5 from V1-C1 intersection, taken the day after (source: AAIU)

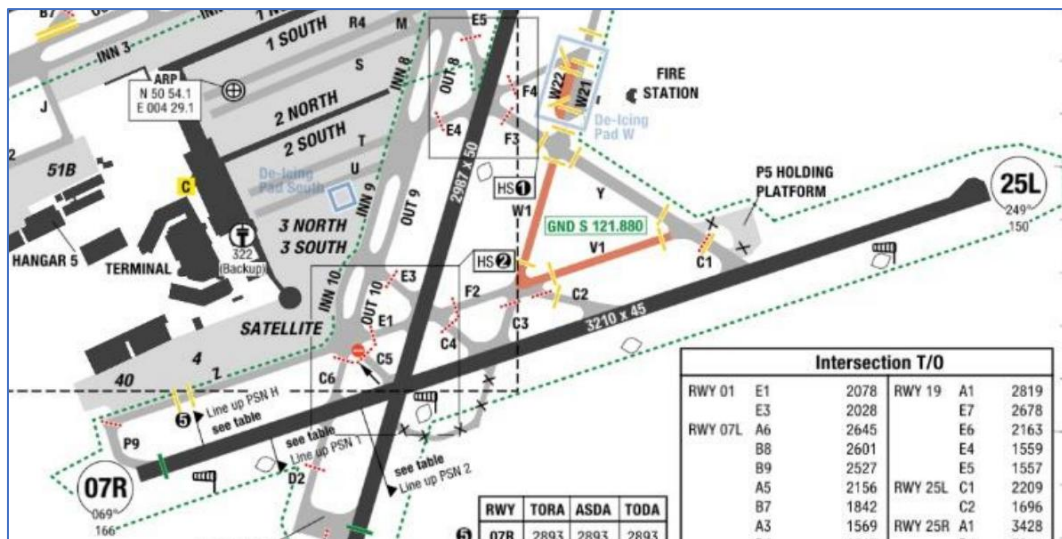
Figure 17 : extract of the ground chart used (source: LIDO – Lufthansa Systems)

The Airport Moving Map (AMM)-functionality— which displays the aircraft’s exact position in real time — was not integrated into the application being used.

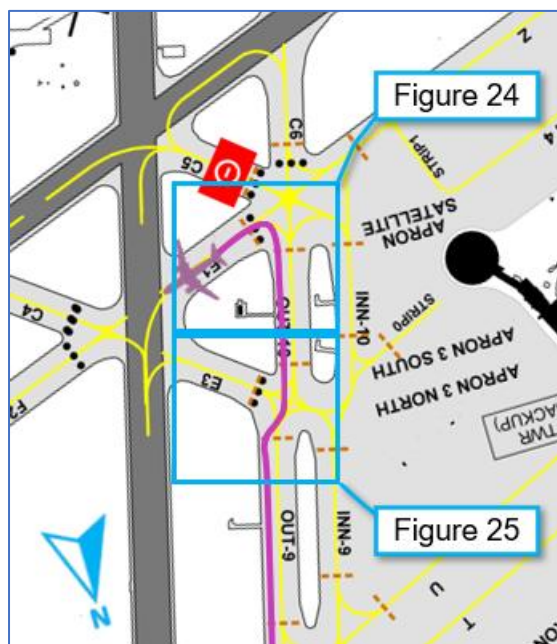
Figure 23 : Indication of the locations of the close-ups shown in Figures 24 and 25, with the magenta line depicting the aircraft's flight path

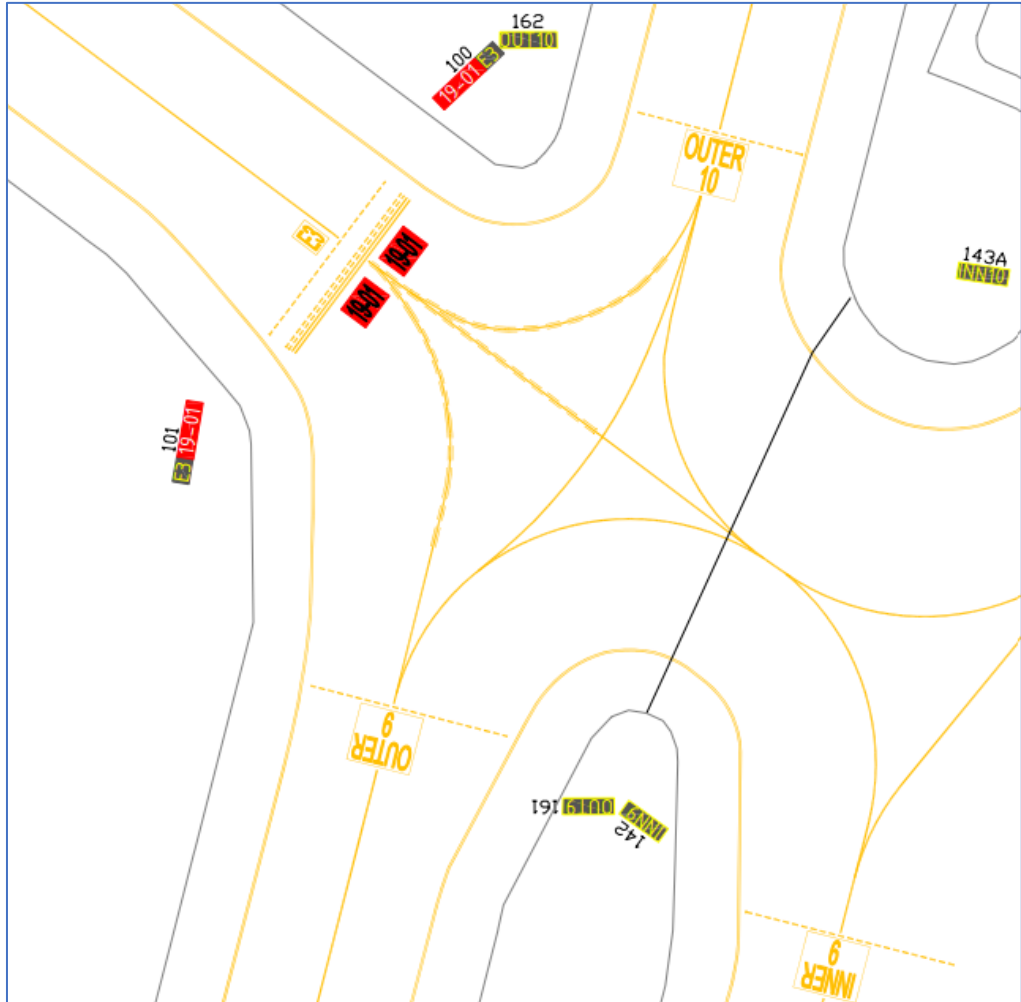
Figure 24 : indication of the signs and painted markings at intersection Outer 9 -Outer 10 – E3
