## Investigation Report.

Status: **Final**  
Date: **27 JAN 08**  
Time: **11.30 UT**  
Type: **Piper PA 18-150 (180 HP)**  
Operator: **Royal Verviers Aviation**  
Registration: **OO-OAW**  
C/N : **4828**  
msn : **18-5346**  
Manufacturing Date: **1957**  
Engine(s): **Lycoming O-360-A4P**  
Crew: **Fatality: 0 / Occupants: 1**  
Aircraft Damage : **Total Loss**  
Location: **EBTX.**  
Phase: **Landing.**  
Nature: **Aerial works, glider towing**  
Departure Airport: **EBTX**  
Destination Airport: **EBTX**  
Flight Number: **N/A**

REF: AAIU (Belgium) 2008-3.

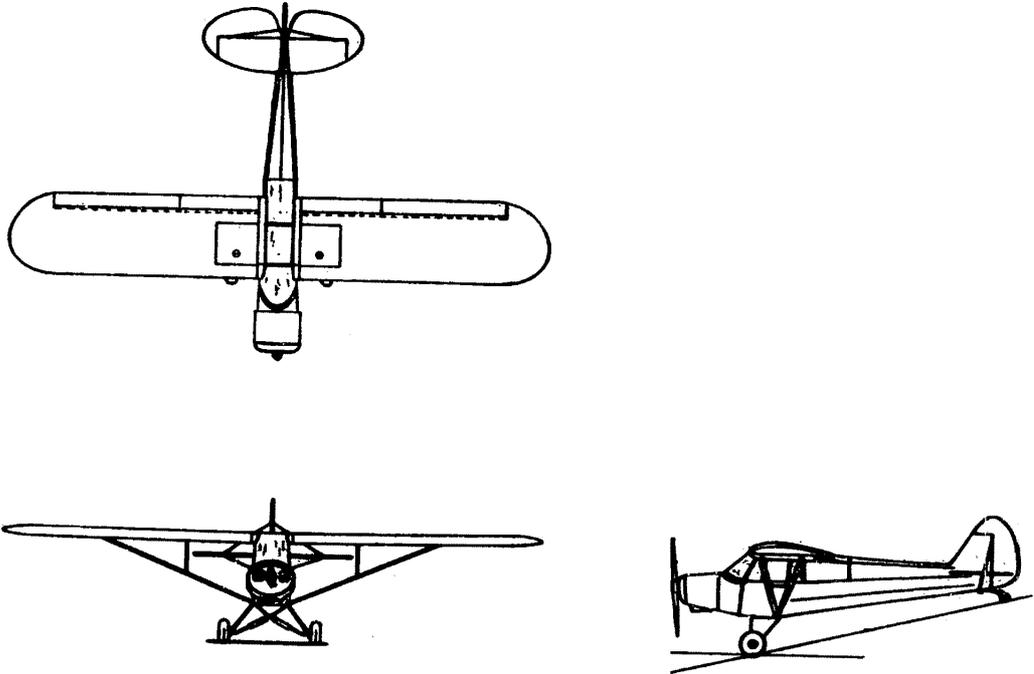
On the crash site, the aircraft was found resting on its undercarriage and nose. The initial impact was at an angle of more than 30°, on the engine compartment. The aircraft bounced back to the right.

The engine compartment is twisted up and left. The metallic propeller shows no significant damage.
