FINAL REPORT ON THE ACCIDENT TO AN ULTRALIGHT AIRCRAFT ON 2 MAY 2009 IN LOKEREN

**Ref. AAIU-2009- 6
Issue date: 4 December 2009
Status: Final**

Type: Self-designed weight-shift controlled ultra-light aircraft.
Referred further to "DPM" – Delta Plane Motorized - in the text.

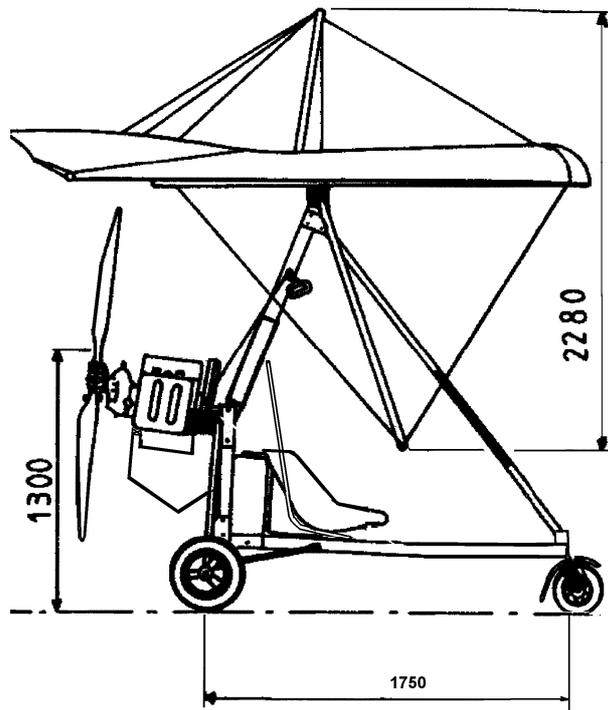
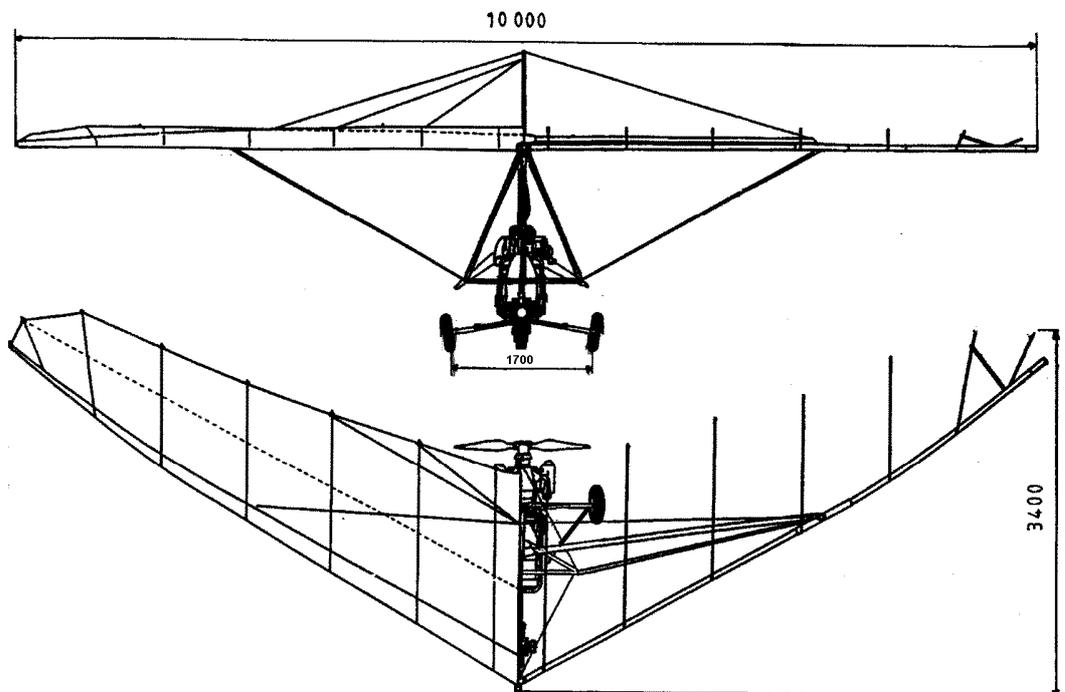
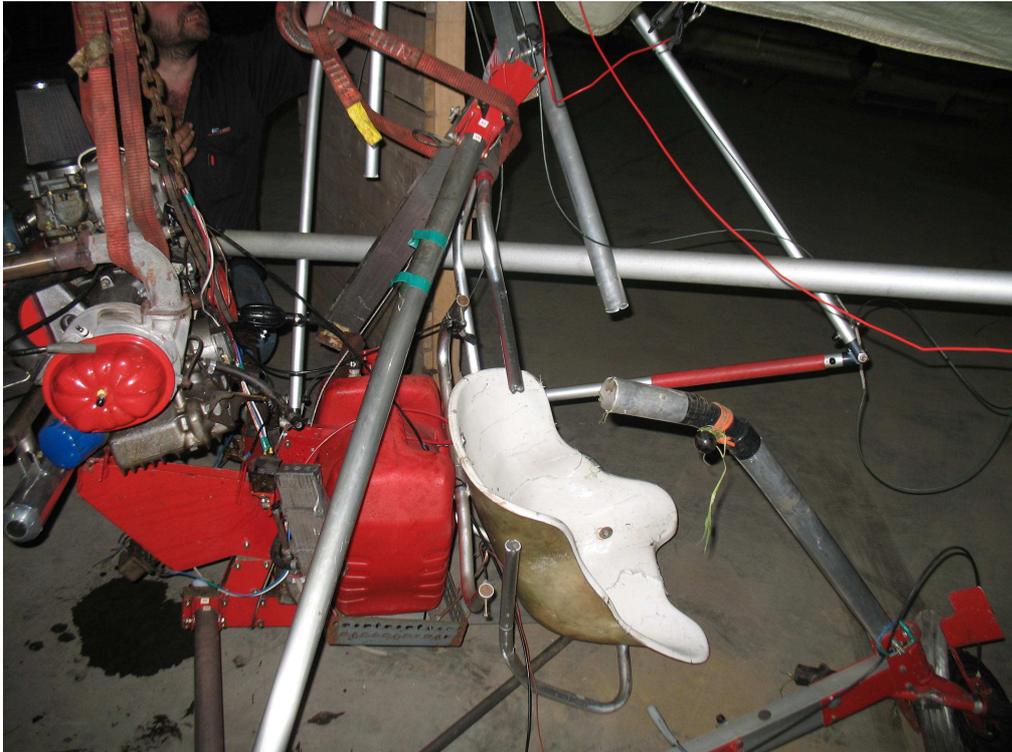
The structure of the kite was heavily damaged;

- the forward beam was severed from the main structure;
- the RH landing gear leg was ruptured in 2 points and severed from the main structure;
- the LH landing gear was bent.
- the roll bar (attachment of the seat) was ruptured.
- the wing attachment bar was ruptured

The structure of the wing was intact, but the connection to the basebar was ruptured.

The propeller was broken upon impact
