FINAL REPORT ON THE ACCIDENT TO THE SAILPLANE LAK-17 AT REGISTERED D-KJGA IN SUARLEE - NAMUR ON 09 MAY 2009

Ref. AAIU-2009-7
Issue date: 25 January 2011
Status: FINAL

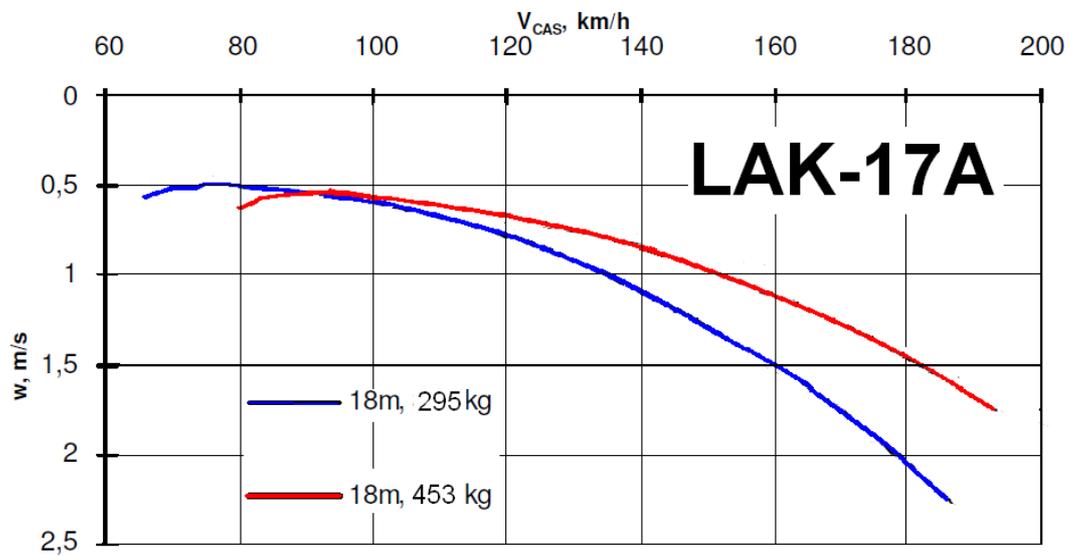
Flap position	Stall speed in level flight, km/h	
	without water ballast	with maximum take off weight
L	69	82
+2	69	84
+1	72	87
0	75	92
-1	76	93

Note: the exact configuration of the sailplane (wing span, winglets) is not specified for this table.

The polars apply to a clean aircraft.

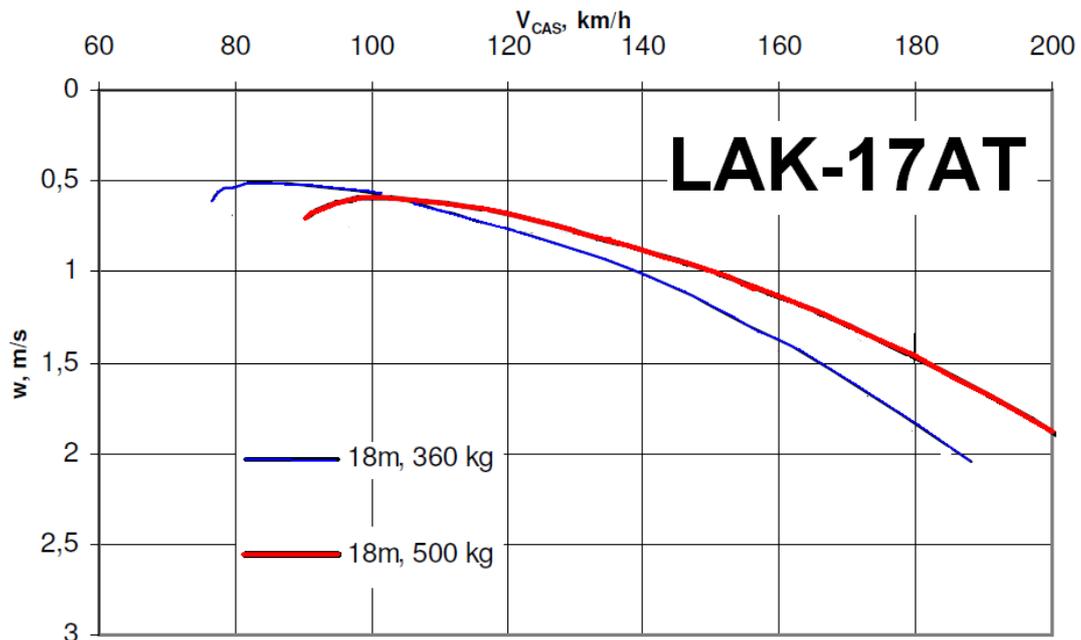
Flap position	Stall speed in level flight, km/h	
	without water ballast	with maximum take off weight
L	85	93
+2	86	94
+1	87	96
0	88	97
-1	89	99

The stall speeds for LAK-17AT were determined in May 2004 by testing a LAK-17AT with power plant extended and propeller stopped.

The polars apply to a clean aircraft, engine retracted.
