FINAL REPORT ON THE ACCIDENT TO RYAN ST3KR REGISTERED N 56028 AT EBDT ON 15 AUGUST 2009

Ref. AAIU-2009-13-EBDT-N 56028
Issue date: 24 October 2011(REV. 21/05/2012)
Status: FINAL

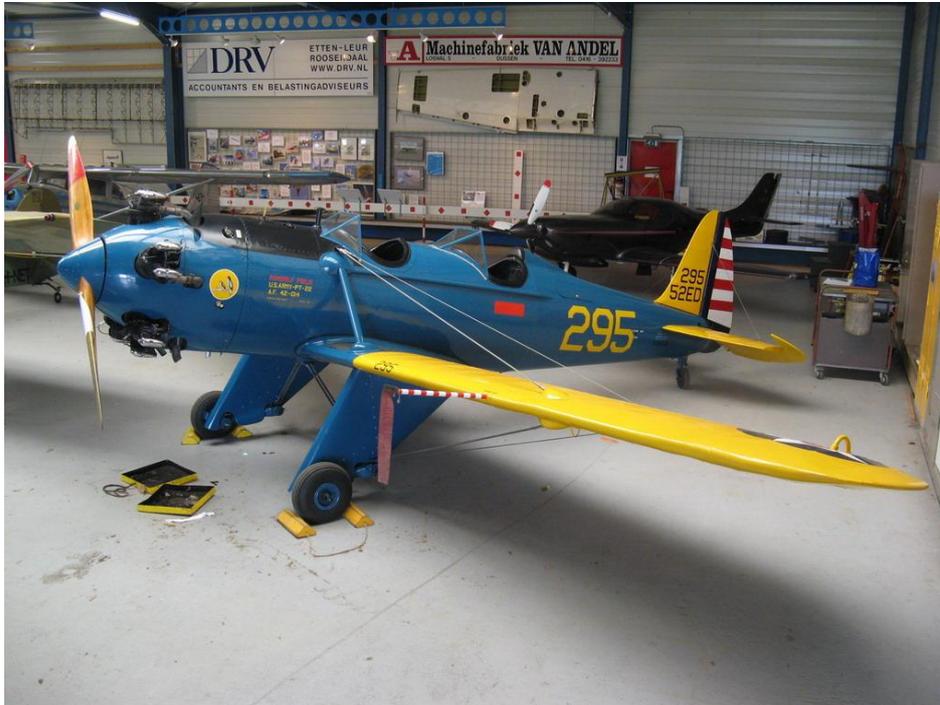
Figure 1

It touched down on the shoulder behind the ditch along the road bordering the airfield. This action was brutally slowed down when the main wheels came in contact with the shoulder of the ditch. Subsequently it hit the fence with concrete poles. The airplane fuselage rotated in a nose down movement which caused the propeller to hit the ground and the airplane to flip over.

The airplane stopped upside down leaving the entire airplane severely damaged.
