FINAL REPORT ON THE ACCIDENT TO THE MISTRAL-C SAILPLANE REGISTERED OO-ZTV IN GOETSENHOVEN ON 23 AUGUST 2009

Ref. AAIU-2009-17
Issue date: 03 SEP 2010
Status: FINAL

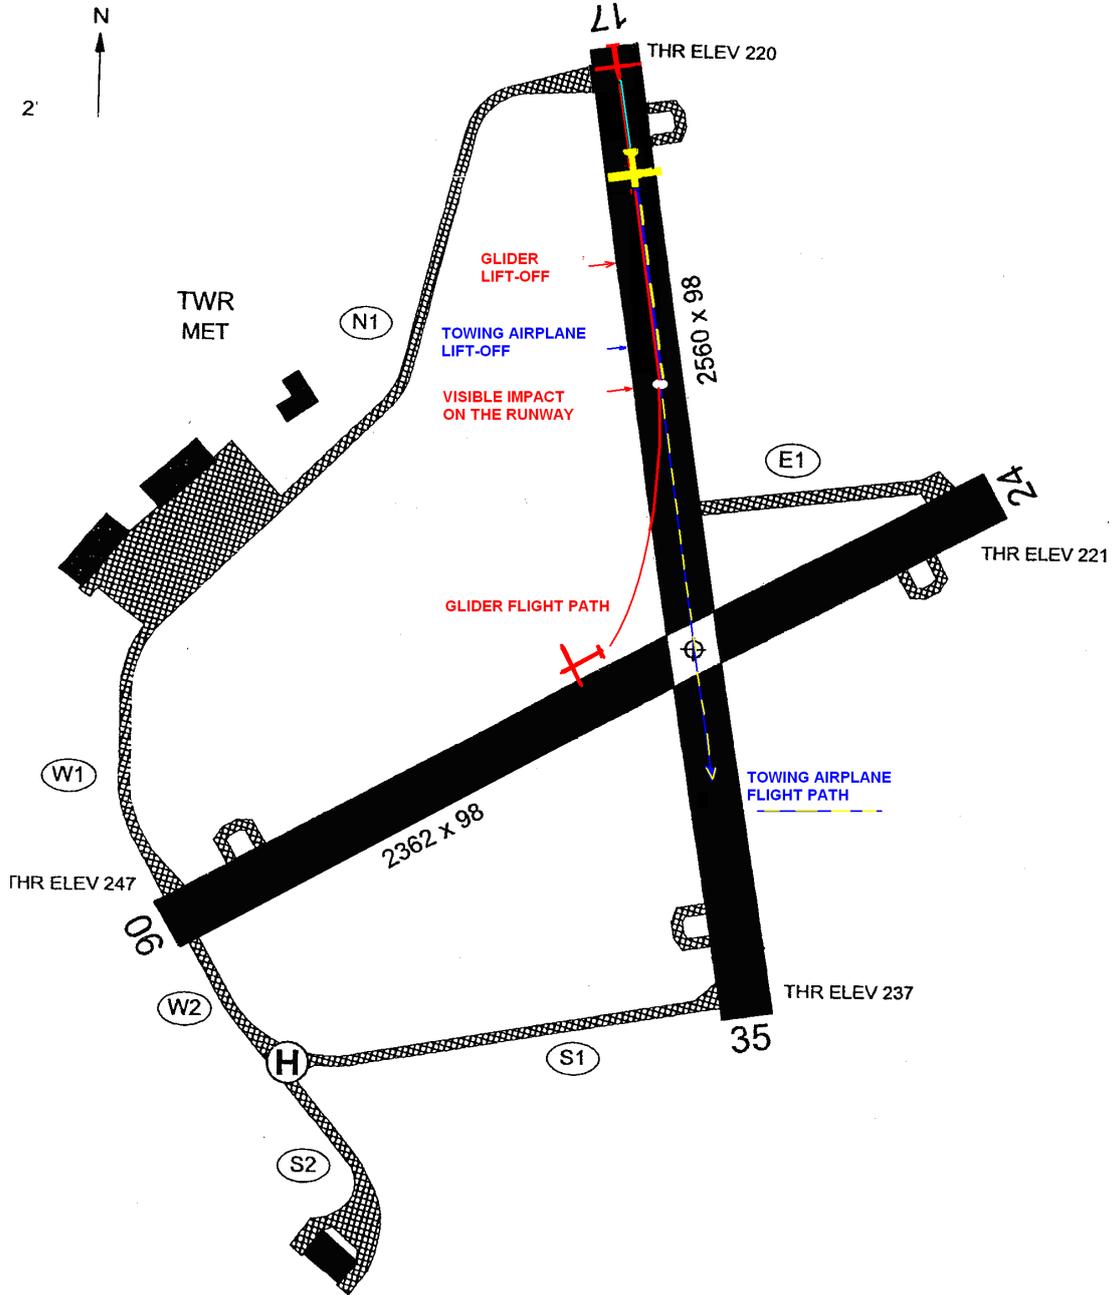
1.12 Wreckage and impact information.

The sailplane impacted the runway two or three times; the last impact was quite violent, and left a white mark on the runway. During this impact, the wing bent downwards and impacted the runway surface.
