## **Safety Investigation Report**

# **TELEDYNE CONTINENTAL MOTOR IO-520-F ENGINE FAILURE ON 09 MAY 2011**

**Ref. AAIU-2011-23-FZEN-OO-A\*\***

**Issue date: 29 June 2012**

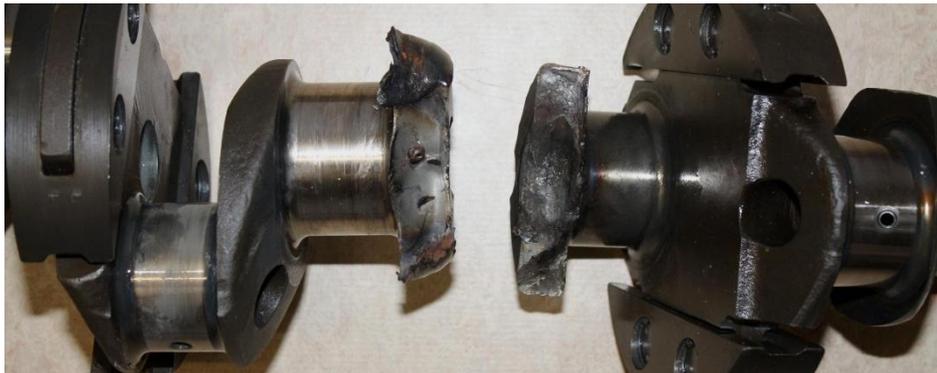
The following identification numbers and markings were found on the crankshaft:

- On the propeller flange: A319111N and "V/U"
- On the cheek number 4: 649130 (Note: two last digits are not certain)
- "VAR" and DU" on the cheek number 6

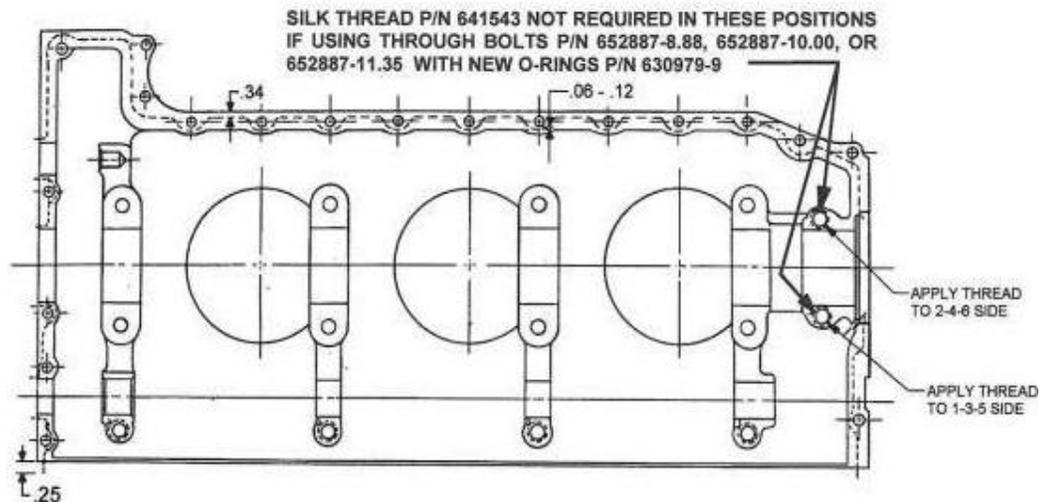
Figure 14: Drawing of SIL99-2B page 15.

Moreover, SIL99-2B provides on page 15 a drawing showing precisely where the silk thread must be installed. (A copy of this page is enclosed at the end of this report).

**FIGURE 6. 0470, I0470, L/I0520, L/TSI0520, I0550 SANDCAST  
ENGINE CRANKCASE THREADING DIAGRAM**
