Safety Investigation Report

ACCIDENT TO AN EUROCOPTER EC120 IN SOUMAGNE ON 18 OCTOBER 2011

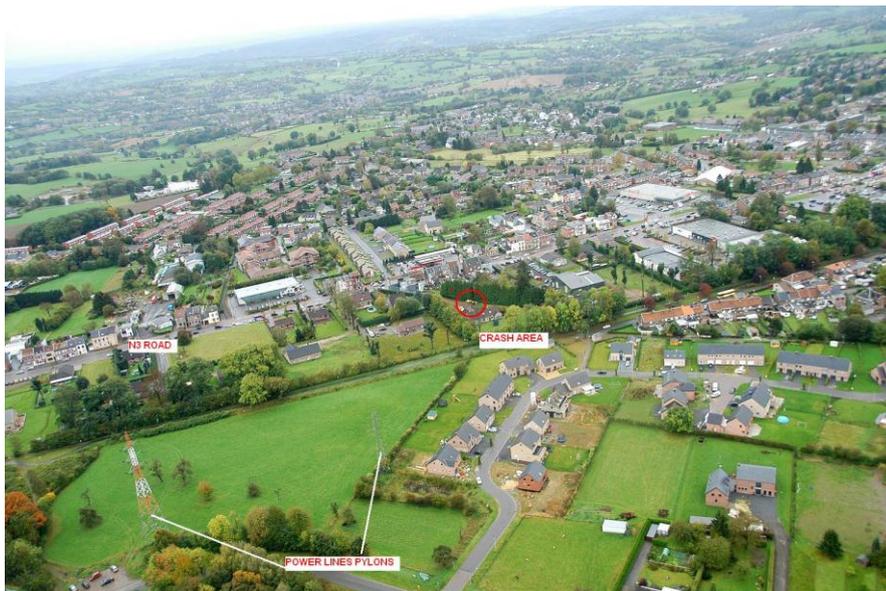
Fig. 11: (Air Support Police Dept) Aerial photography taken above the E40 highway

The wreckage lies in the garden of a house close to the N3 road, at 300m from the E40 highway (Liege – Verviers). Small parts of the helicopter were found in the gardens in the vicinity.

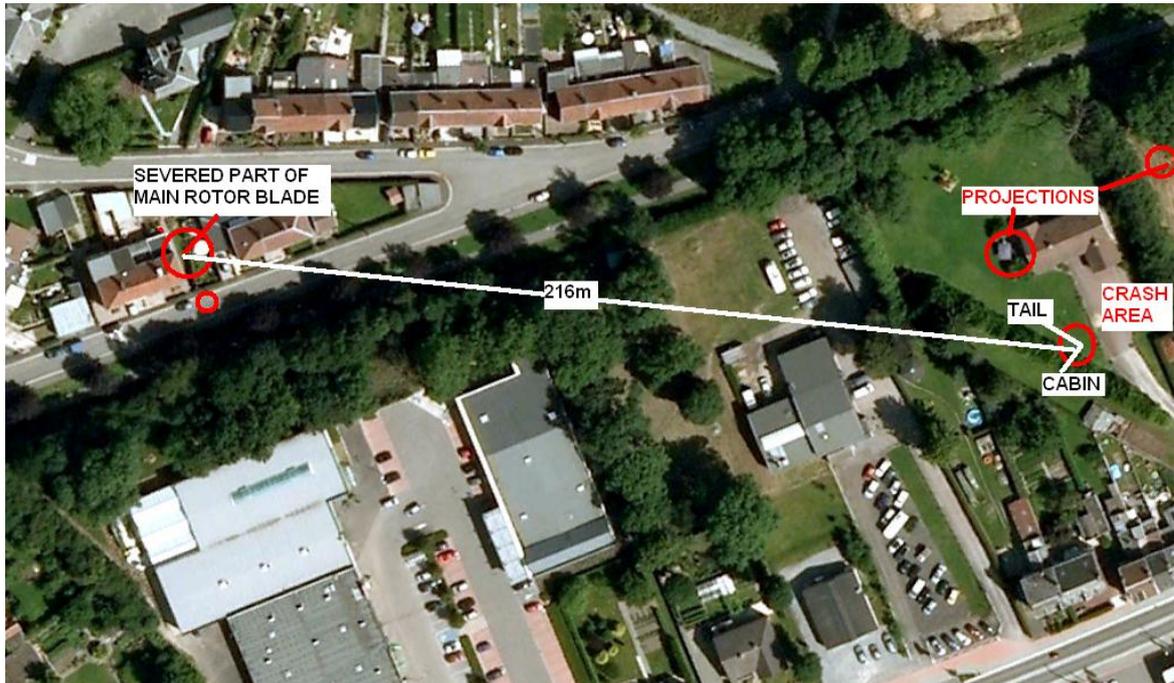
Fig 12. Crash area

Impact damage in the yard of the house where the helicopter crashed;

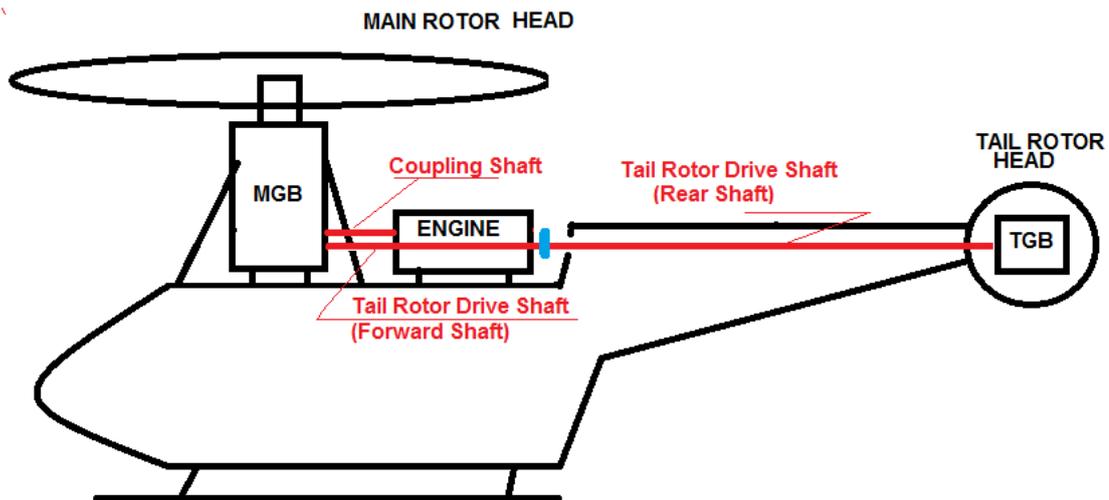
Engine.

The engine was in good mechanical condition, and the detailed examination determined that it was delivering significant power at the moment of impact;

- The magnetic particles detectors were clean, as the oil filter; indicating that there was no indication of abnormal wear.
- There were particles visible inside the combustion chamber, as well as in the turbine section. These particles are from the abrasible coating around the centrifugal impeller, indicating a brutal axial movement of the rotating parts of the engine when the helicopter impacted the ground.

- There were traces of beat on the splines of the transmission shaft sleeve and on the muff coupling (Main Gear Box) indicating that the engine was running at the moment of the disengagement of the coupling shaft.

- The engine was still attached to the structure of the helicopter. The damage were consistent with the impact forces.

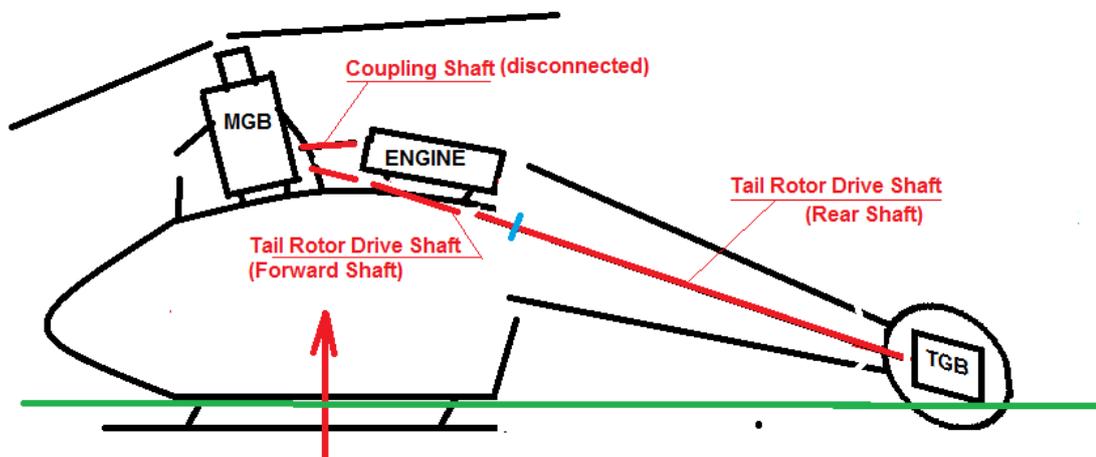
Main Gearbox (MGB)

- By turning the Main Rotor Head, it was still possible to drive the input and output pinion, confirming the mechanical continuity inside the Main Gearbox.
- The Main Gearbox was still attached to the helicopter structure; three out of four suspension bars, holding the MGB in place are deformed and one is broken by overload.
- The damages seen on the drive splines of both input pinion and Tail Rotor Drive shaft are consistent with an uncoupling under power at impact, due to the deformations of the helicopter structure.
