FINAL REPORT ON THE INCIDENT TO AVRO RJ85 REGISTERED OO-DJK ON FRIDAY 11 FEBRUARY 2011

Ref: AAIU-2011-02-Marseille-OO-DJK

Issue date: 14 October, 2011

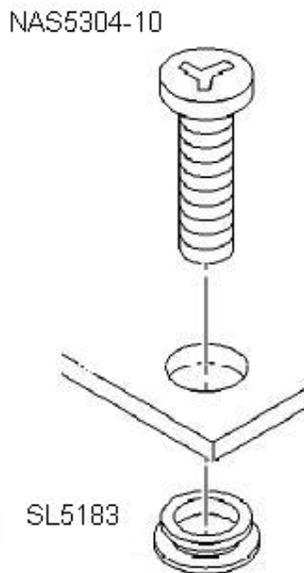
Figure 5: Exploded view of SL5183 installation

In production, the panel was installed by 25 internal wrenching bolts (NAS5304-10) through steel grommets (SL5183) used as reinforcement of the composite holes. During manufacturing these grommets are inserted into the panels, prior to the grommet flanges being peened over on the upper surface of the panel using a special tool and a hammer (See Figure 5 and Figure 6). The bolts are held by anchor nuts.

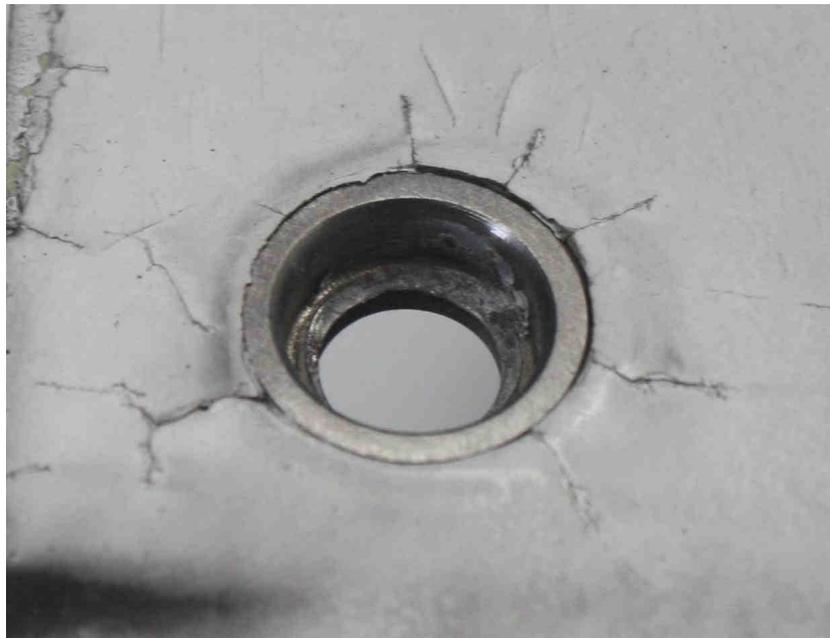
Figure 8: Installed SL5183

The main problem with the initial grommets (SL5183) is the peening process. When not applying the right process with the correct tool, it can occur that the grommet gets cracked or there is an excessive waisting of the material. This can happen during maintenance but BAe systems recognised this also could have occurred during initial production.

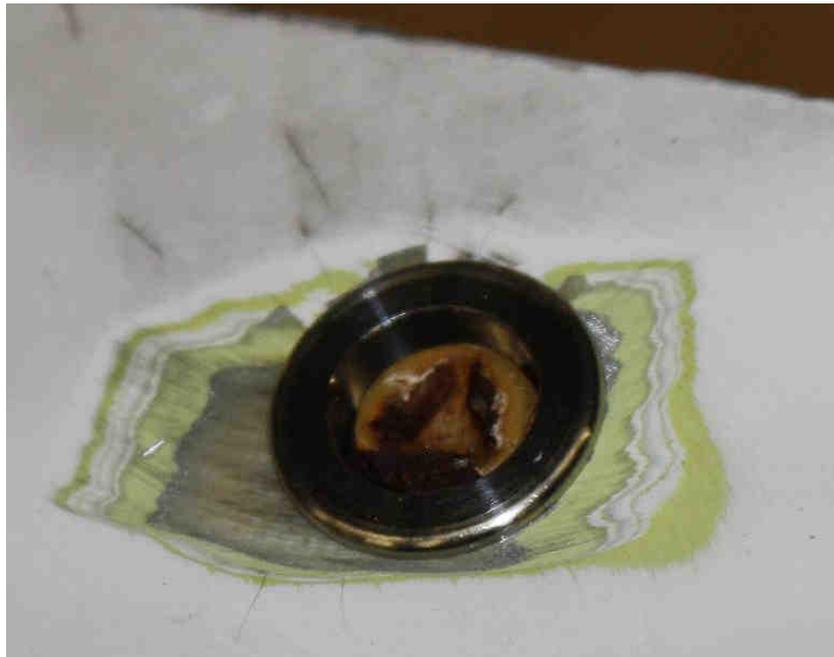
Figure 10: Installed SL5185

Comparing Figure 7 and Figure 9 it is obvious that there's a change of design and the new grommets have a larger and thicker collar.

found, the grommet has to be replaced by a redesigned grommet (PN SL5185) which has to be inserted into the panel from the external side. See Figure 9.

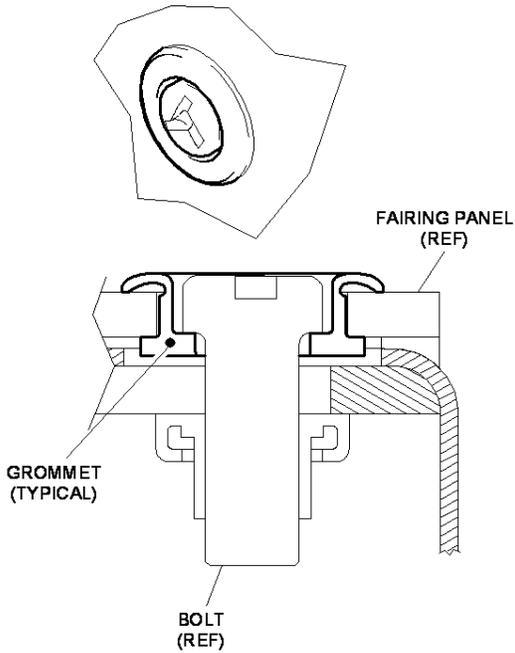
GOOD GROMMET IN-SITU
