Safety Investigation Report

ACCIDENT TO DPM MICROBEL EQUIPPED WITH ORYX WING AT ISIERES ON 7 SEPTEMBER 2013

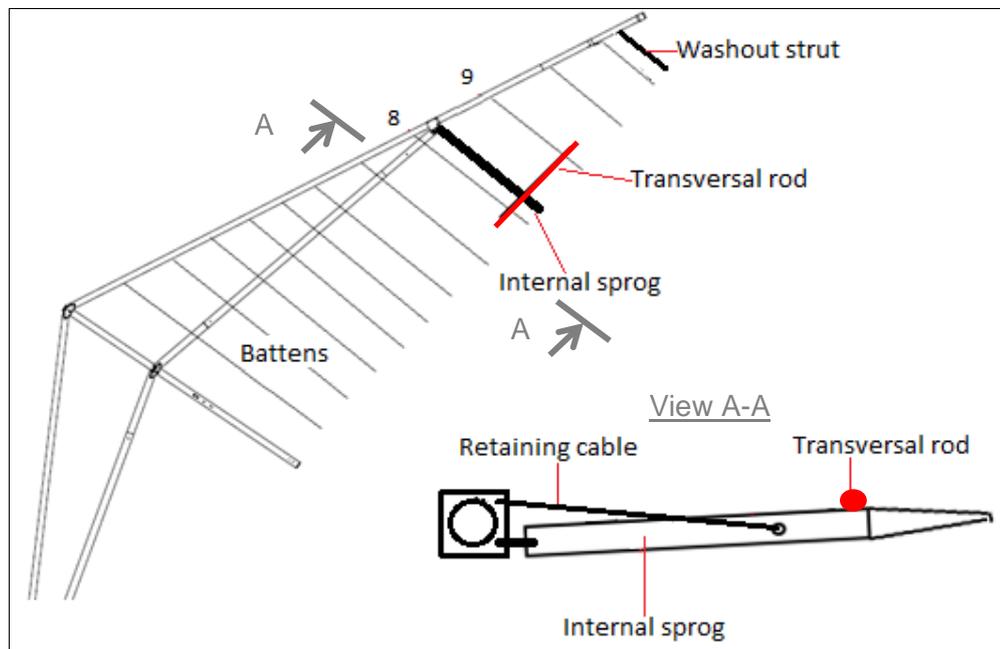
Figure 4: Oryx Wing Reflex System

The reflex system of the Oryx wing is comparable to the one shown on the above drawing. It features:

- Washout struts – longitudinal tubes fixed near the tips keeping the tip trailing edges up. (NB: Washout struts are used both for wings with or without king post).
- Internal sprogs (called also internal washout sprogs), combined with transversal rods, are maintaining the position of the internal wing trailing edges. This is a typical design for wings with side struts and no king post.

The purpose of the internal sprog is to hold onto place the transversal rod and consequently also the battens N° 8 and 9 causing an upward twist of the trailing edge

The transversal rods, part of the reflex system (see § 1.6 Aircraft Information), were not found in the wreckage. The transversal rod pocket was found empty. The transversal rods were found later, stored in the pilot's closet in the aero club building.

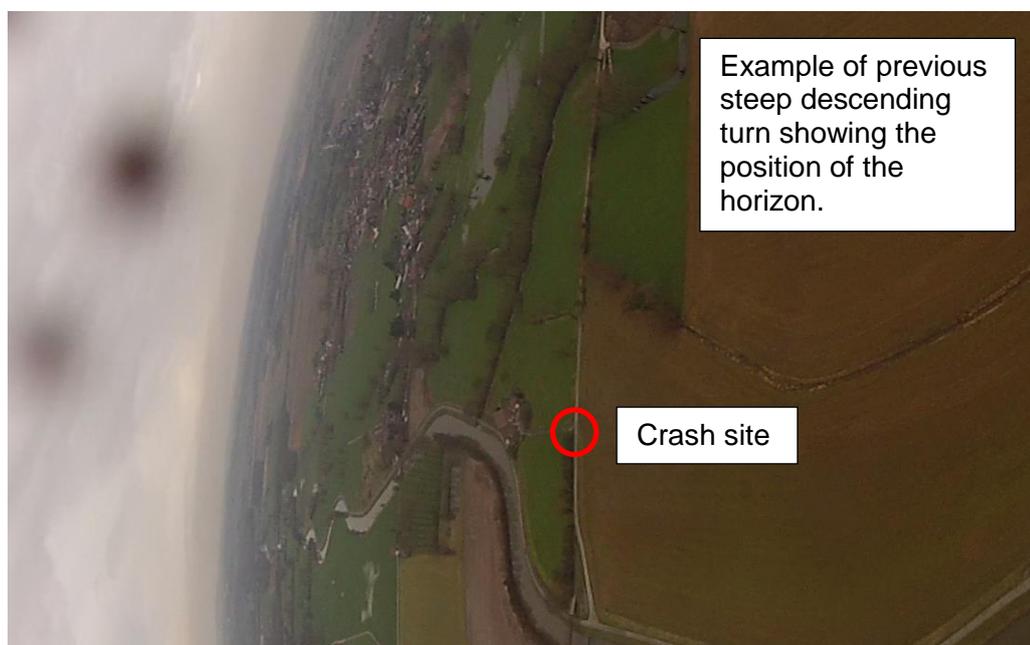
Figure 7: Example of steep descending turns originating from the GoPro camera.

Amongst other, one GoPro record shows the DPM diving and making a steep 720° turn in 17 seconds near the airfield, before directly landing. This video was taken when the DPM was still equipped with the old La Mouette Chronos Top 12.9 wing.

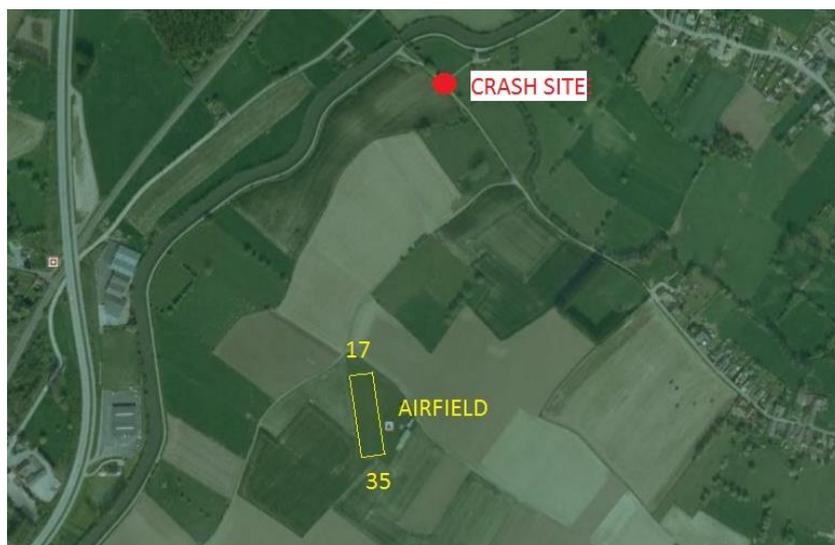
Figure 8: Location of the crash site

The aircraft crashed on the Chemin de la Tourette, in the village of Isières at a distance of 600 m from the EBIS airfield, near the Dendre river. The area is flat, with cultivated fields. The actual position of the wreckage is N 50° 40' 07.8" – E 3° 48' 24.0".

The aircraft hit the ground at a steep flight path angle and left a trace on the pavement. The aircraft bounced and came to a halt four meters further. The first impact area shows damage to the trees, including remnants of the wing cover and traces of oil and gasoline on the pavement.

The wing itself, with the trike still attached, was resting 4 meters away showing multiple fractures to the structure.
