Safety Investigation Report

ACCIDENT B&F TECHNIK FK12 COMET AT EBAV AIRFIELD ON 29 AUGUST 2013

Ref. AAIU-2013-AII-07
Issue date: 17 March 2015
Status: Final

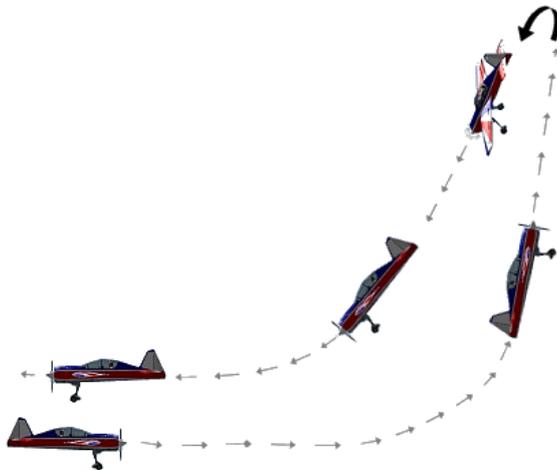
Figure 5: drawing of a wingover manoeuvre.

After each wingover executed at the end of the runways the aeroplane levelled off in an opposite direction and flew horizontally above the runways at high speed and very low altitude (10 to 15 meters above the ground as stated by the witness).
