Safety Investigation Report

ACCIDENT TO CESSNA P210N AT EBCI ON 9 FEBRUARY 2013

Ref. AAIU-2013-04
Issue date: 27 March 2014
Status: Final

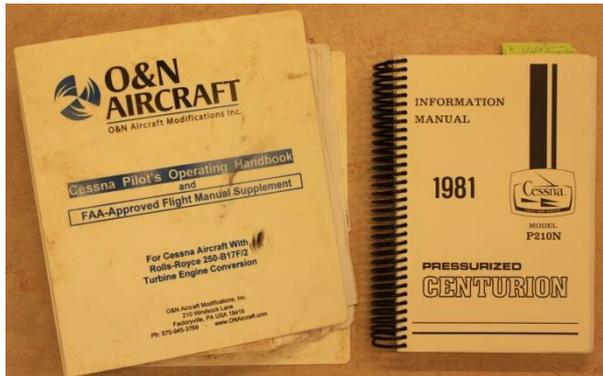
Figure 4: O&N AFMS and original Information Manual.

No original Cessna AFM or POH applicable to P210N airplane was found in the wreckage. By contrast a FAA approved Airplane Flight Manual Supplement (AFMS) for Cessna P210N with Allison Engine was retrieved around the wreckage.

On the left side of the picture, the AFMS present in the wreckage and on the right an "Information Manual" provided by Cessna for the purpose of the investigation.
