Federal Public Service
Mobility and Transport
Air Accident Investigation Unit

Safety Investigation Report

ACCIDENT TO A ROBINSON R-44 IN ROESELARE ON 5 SEPTEMBER 2014

Ref. AAIU-2014-20- Roeselare
Issue date: 15 December 2015
Status: Final

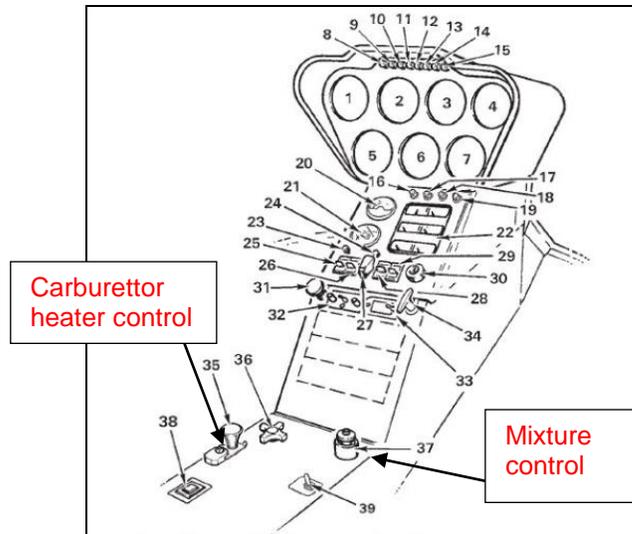
Figure 3: Instrument panel

In the cockpit of the R44 a carburetor air temperature (CAT) gauge is installed, which is wired to a temperature probe in the carburetor downstream of the throttle butterfly valve. This allows the flight crew to monitor the temperature within the carburetor. When the needle is in the yellow caution band (see Figure 19), carb heat has to be applied by pulling the carb heat control (see Figure 3).

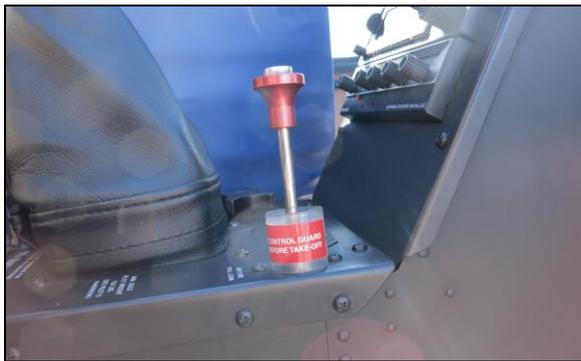
Figure 4: Mixture control (idle cut-off)

The sheath of the mixture cable is found still attached at its last attaching point on the oil sump. The carburetor end of the steel wire stops exactly at the end of the sheath.

The other end of the mixture control was found fully pulled back meaning it was in cut off position. The sheath of the mixture control shows few signs of elongation.

There was no trace of the plastic mixture guard found on the mixture control or in the wreckage.

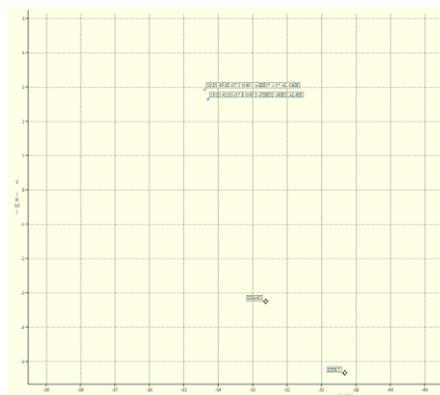
Figure 8: Accident flight – radar data

The first detection after take-off from Roeselare is at 18:01:45.65 in mode A/C, followed by a primary only track update (with same track number as the first detection in mode A/C) at 18:01:49.60. Thereafter no detections of the aircraft are found. Last reported altitude was 400 feet; QNH 1014 hPa = +-25 feet correction = 425 feet or +-130m height.

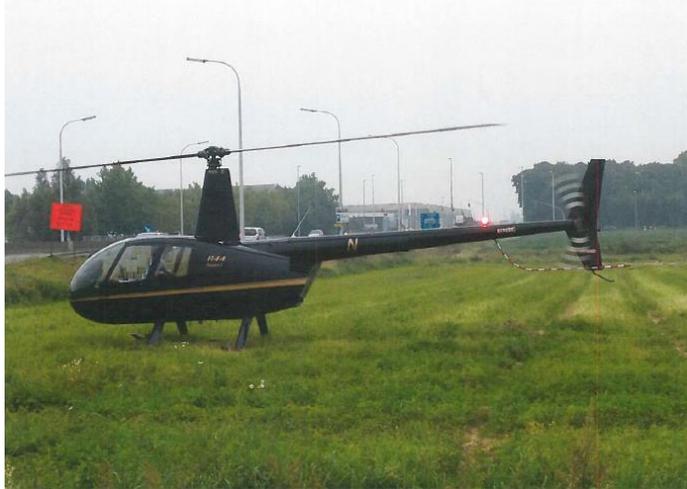
Figure 9: helicopter landing after the flight from EBKT

After the accident, the man who held a valid pilot certificate was found sitting on the left seat while the student pilot was sitting on the right seat. The picture (figure 9) showing the helicopter after landing shows the same seating configuration (faces blurred), and the control column in position for a pilot-in-command on the right hand side. The cyclic is center-mounted to a cross tube which pivots on the center cyclic post. On the picture, the left grip is visible when zooming in, meaning the right side was used to control the helicopter.
