# Safety Investigation Report

Ref. AAIU-2015-11  
Issue date: 27 April 2016  
Status: Final

An aircraft part was found in a privately owned garden located near to the airport of Liege, Belgium (EBLG).

The part fell down from a B737 airplane, on approach to EBLG.

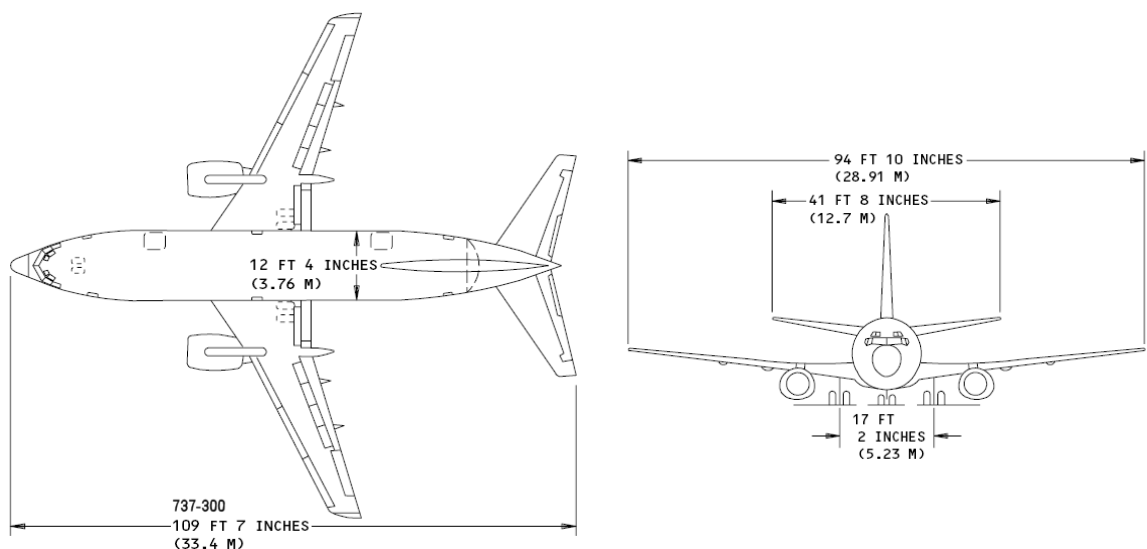
Figure 7

The 737 Dispatch Deviations Guide indicates (chapter 57-53-03) that the airplane may be flown with one or both inboard flap/inboard seal plates missing with reduced Performance limited weights (147kg in take-off and landings) and 204kg (en-route and climb).
