Safety Investigation Report

Ref. AAIU-2015-11
Issue date: 27 April 2016
Status: Final

Classification:	Serious incident
Level of investigation:	Standard
Date and time:	31 July 2015 – 11:30 UTC
Aircraft:	Boeing B737-4Q8, msn 27628
Operator:	Tailwind Airlines
Date of Manufacture:	February 1997
Type of engine:	Two CFM-56-3
Accident location:	At the moment of the incident: Above St Georges sur Meuse, on approach to EBLG airport.
Type of flight:	Commercial
Phase:	Landing
Injuries:	None

Other – Things Falling-Off Aircraft (TFOA)

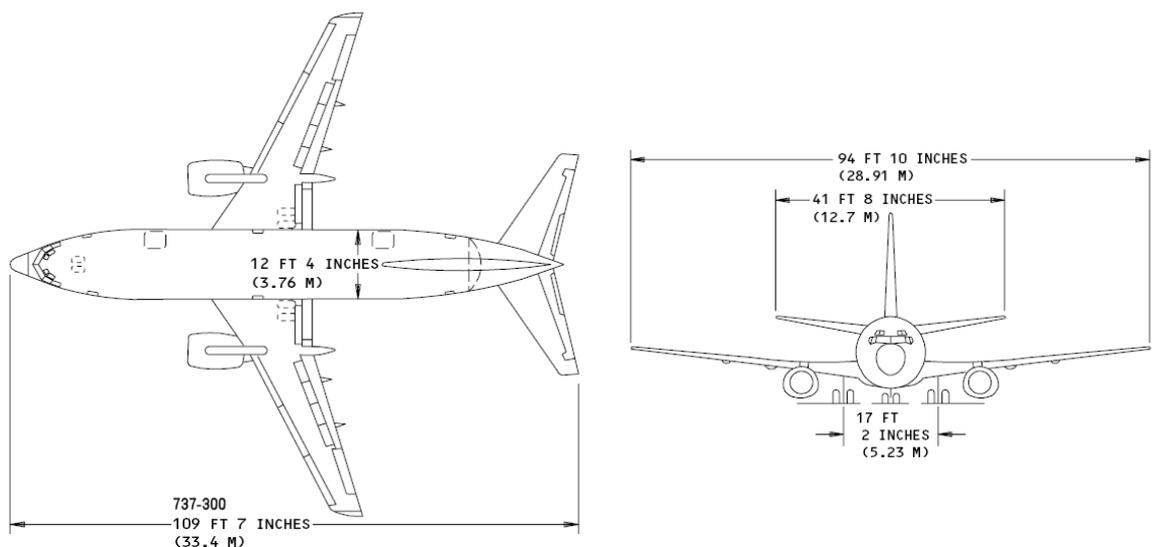
Figure 7

The 737 Dispatch Deviations Guide indicates (chapter 57-53-03) that the airplane may be flown with one or both inboard flap/inboard seal plates missing with reduced Performance limited weights (147kg in take-off and landings) and 204kg (en-route and climb).
