Federal Public Service
Mobility and Transport
Air Accident Investigation Unit

Safety Investigation Report

SERIOUS INCIDENT SOCATA TBM 700 A AT AERODROME GENK / ZWARTBERG ON 17 DECEMBER 2015

Ref.:
AAIU-2015-16

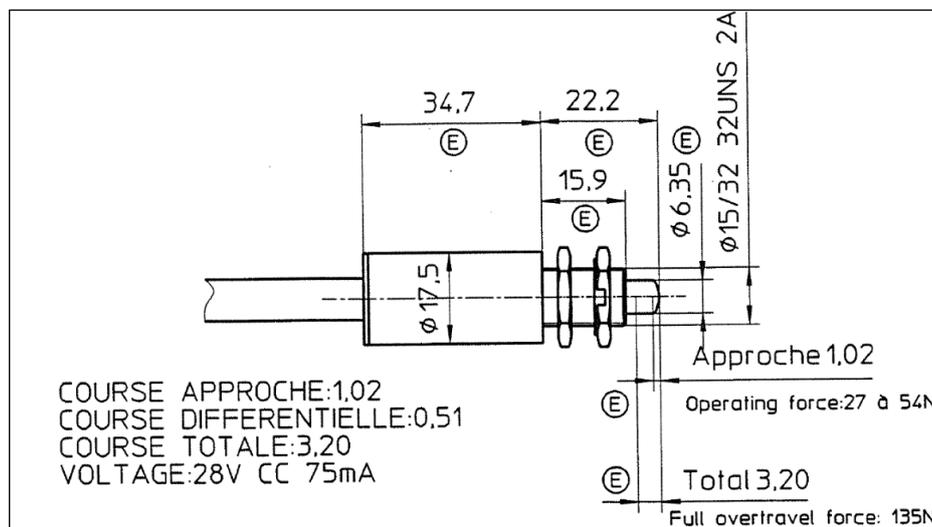
Figure 15: Drawing showing the dimensions of a dual switch

The movement of the dual switch is very short, and its setting is very sensitive. By design, the first internal micro switch is activated after 1.02 mm before that the second micro switch is activated 0.51 mm further, after 1.53 mm.

The procedure to adjust a dual switch on its holder requires that, after the activation of the second micro switch, it must be further turned between $\frac{1}{4}$ and $\frac{1}{2}$ turn which

corresponds to 0.2 to 0.4 mm of longitudinal displacement of the dual switch². The full movement of the dual switch moving part is between 1.73 mm and 1.93 mm.

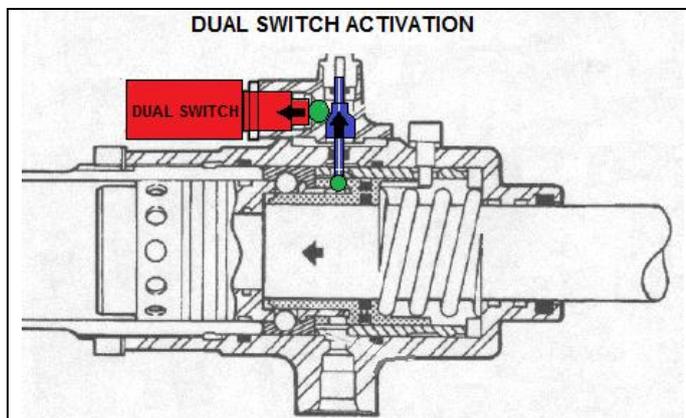
Figure 16: dual switch activation mechanism

When the actuator piston has run its course and locks, a plunger is pushed upwards by a ball operated by the movement of the locking mechanism inside the actuator.

The conical section of the plunger converts the vertical movement into a horizontal movement and pushes on another ball transferring the movement and finally activating the dual switch.

A latest improvement of the plunger was introduced in December 2012 (MOD70-0334-32) to replace the original design with an improved “differential” plunger intended to provide an additional load, helping the return course. As stated by Daher-Socata, this differential plunger offers a considerable improvement causing a reduction of the indicating kinematics malfunctions. However, Daher-Socata stated that residual malfunctions may still exist, although they are much limited in number.

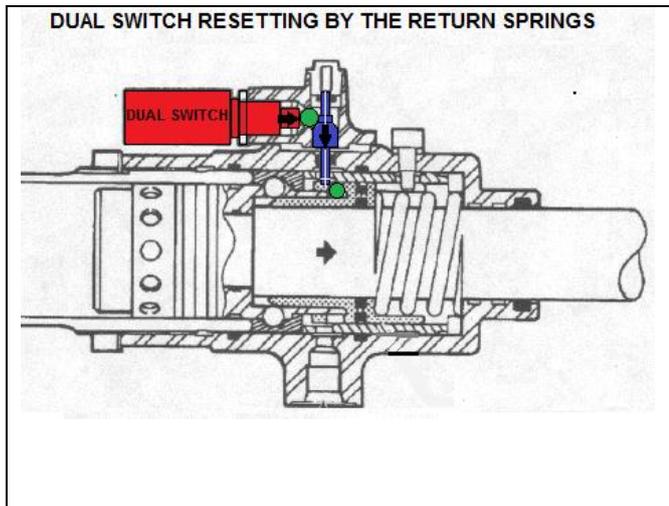
Figure 17: dual switch resetting mechanism

When the piston of the actuator unlocks and moves, the internal locking mechanism displaces its ball with the effect of releasing the vertical force applied to the plunger.

- It is also possible that the quantity of thick liquid under the plunger was most of the time not sufficient to disturb the deactivation of the dual switch while it was sufficient to prevent its full return stroke. In that case, the plunger position would have remained very close to the activation position meaning that any small upwards movement possibly caused by a pressure spike in the hydraulic circuit could have cause an unwanted activation of the dual switch. However, Daher-Socata considers that this explanation is not relevant since the plunger diameter has functional play in the bore where it travels.

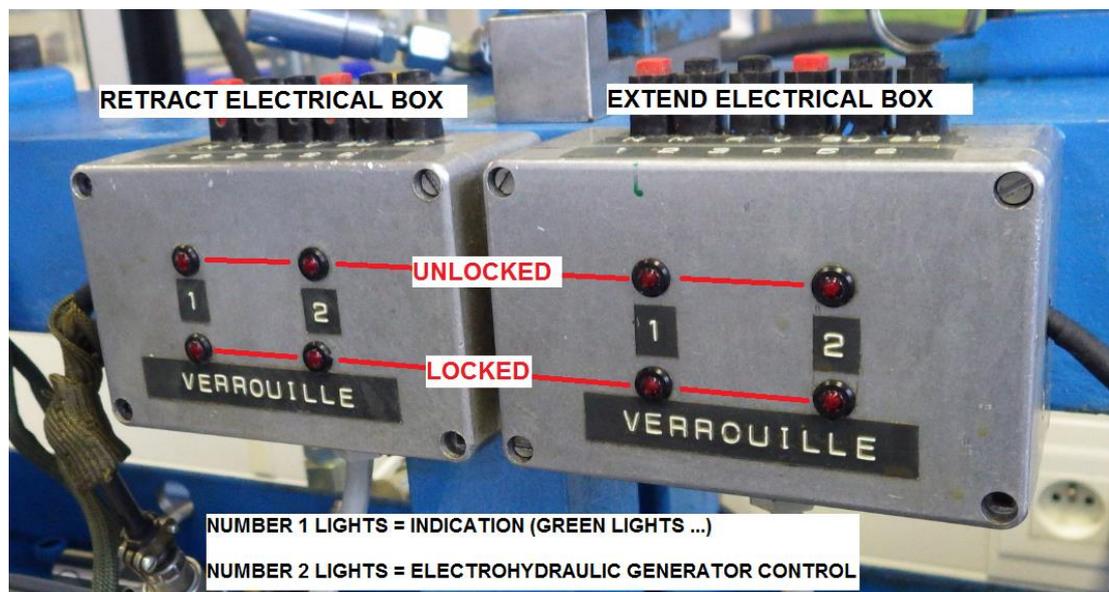
Figure 21: Test bench limit switches indication lights

Each electrical box is equipped with 4 red lights. Two lights located at the bottom of the boxes are triggered ON when the dual switch is activated, i.e. when the actuator is in locked position. The 2 lights located at the top are triggered ON as soon as the actuator unlocks. The lights on the left side of each box are used to test the switch for the indication system (Green lights etc) while the lights on the right side are used to verify the switch used to control the electro-hydraulic generator.

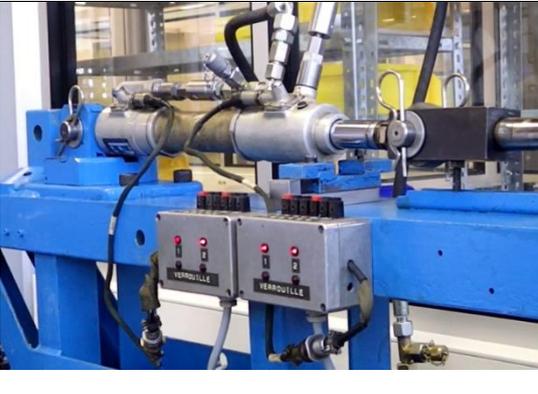
<p>At the end of the retraction phase, normal activation of the retract dual switch contacts.</p> <p>But almost at the same time both 2 extend dual switch contacts also activated to the locked position.</p> <p>Thus abnormal activation of the “extend” dual switch contacts when the actuator locked in retract.</p>

A possible cause of this unwanted activation of the dual switch would be that a pressure spike in the hydraulic circuit was produced internally at the end of the retraction course, causing an upwards movement of the “extend” plunger. This type of phenomenon is not a unique case as it is also described in the investigation report BEAD-air-A-2008-004-I dated February 2009.

During the last retraction performed after the take-off at EBLG airport, it is likely that the plunger did not move fully down. This might have been caused by the presence of abundant low viscosity grease on the underside of the plunger, causing a cushion effect and reducing the movement of the plunger.

In this case, a very small upwards movement of the plunger, possibly caused by a pressure spike, has the potential to cause an early activation of the dual switch.

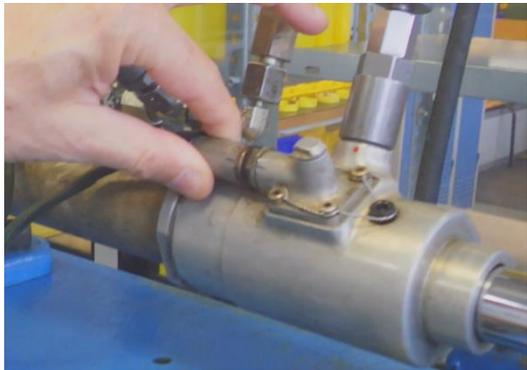
Actuator and dual switch plunger examination

External examination of the actuator showed that a lock plate washer used to secure the assembly of a guide rod with the casing of the actuator was not bent, but the parts were not loose. The plug of one plunger holder was also found to be damaged by a previous use of an inadequate wrench for unscrewing it. Finally, traces of hydraulic oil seepage were visible around the extend dual switch holder.

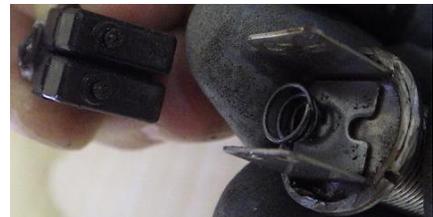
Figure 25: dual switch dismantling

A CT-scan of the dual switch was performed at the BEA facility in Le Bourget, France. Nothing abnormal was detected.

Thereafter, the switch was disassembled. No electrical or mechanical anomaly and no contamination was found.

Examination of the construction of the dual switch, made of 2 independent micro switches operated by a simple mechanical plate cannot explain the cause of the blockage or dampening as seen during testing.
