# Safety Investigation Report

## ACCIDENT B&F TECHNIK, MODEL FK12 COMET AT AVERNAS ON 18 OCTOBER 2015

**Ref.:**  
AAIU-2015-AII-12

**Issue date:**  
05 January 2017

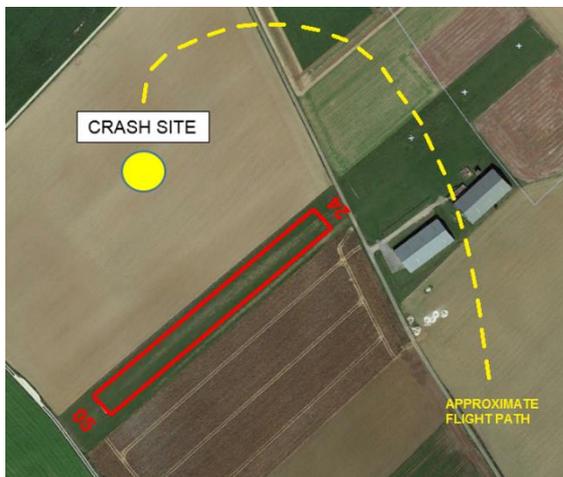
Figure 4: Approximate flight path and the crash site position.

The aeroplane took off for a second flight of the day from EBAV airfield at 10:50. A few minutes later, the aeroplane was seen on fire and returning to the airfield by witnesses. The aeroplane flew over the airfield and crashed in a neighbouring field, 250m from the airfield's hangars. The aeroplane flipped over upon impact and the wreckage burned completely. The pilot died in the wreckage.

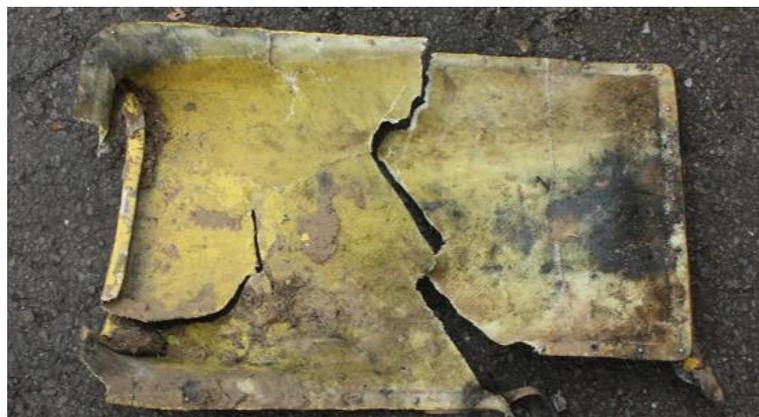
Figure 14: air intake of the water cooler located below the lower engine cowling

The upper and the right side engine cowlings had been retrieved as well as the lower part of the ducting used to route the ram air through the water cooler.
