Safety Investigation Report

Ref. AAIU-2016-AII-04
Issue date: 3 January 2018
Status: Final – Revision 1

Classification:	Accident
Level of investigation:	Standard
Date and time:	11 June 2016 at 16:50 UTC
Aircraft:	ATEC Zephyr 2000 ultralight aeroplane
Owner:	Private
Location:	Along the highway E42, near the exit “Malmedy”.
Type of flight:	General aviation – Local flight
Phase:	Cruise
Occurrence type:	System/component failure or malfunction non-powerplant (SCF-NP)
Persons on board:	One pilot and one passenger
Injuries:	None

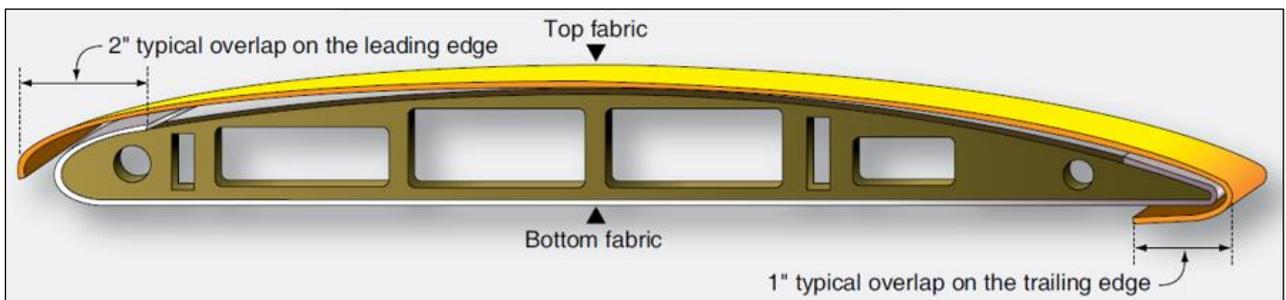
Figure 10: sketch of a standard design for the fabric covering.

The ATEC design for the fabric covering (see sketch on Figure 9) is characterized by 3 fundamental differences with respect to the usual covering method:

It shows typical overlaps at the leading and trailing edges, whose goal is to ensure that:
