# Safety Investigation Report

Ref.:  
AAIU-2019-12-29-01

**ACCIDENT  
ROBINSON R44  
AT WIJNENDALE (TORHOUT)  
ON 29 DECEMBER 2019**

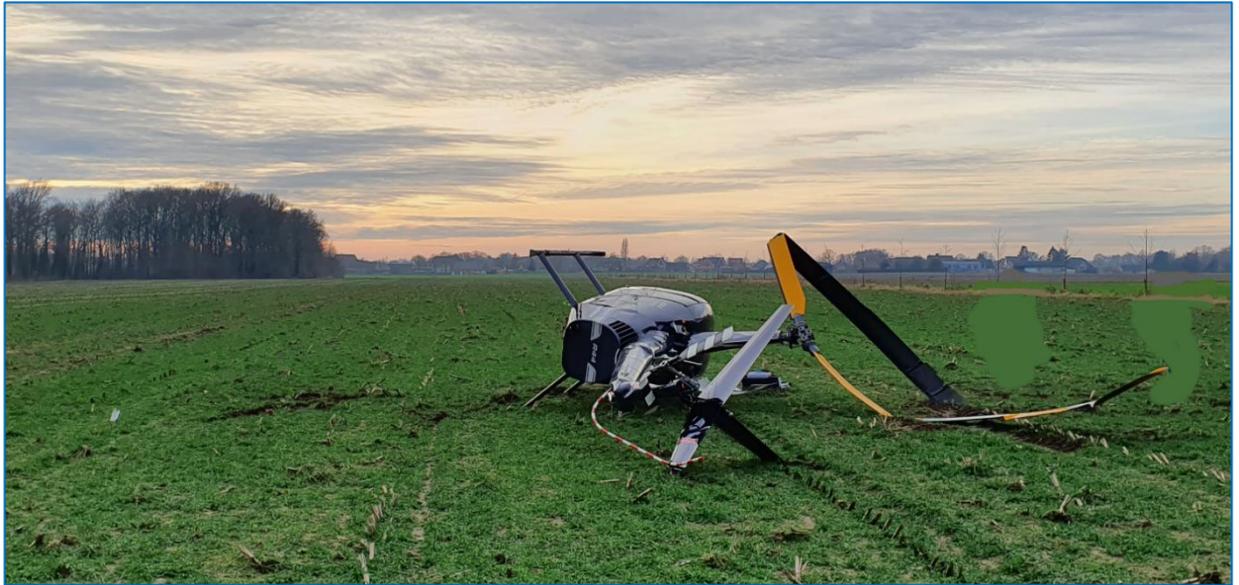
Figure 2 The crash location

At one nautical mile from his final destination, the helicopter crash landed in a bare agricultural field in Wijnendale (see figures 2 & 3). The total flight took exact one hour.

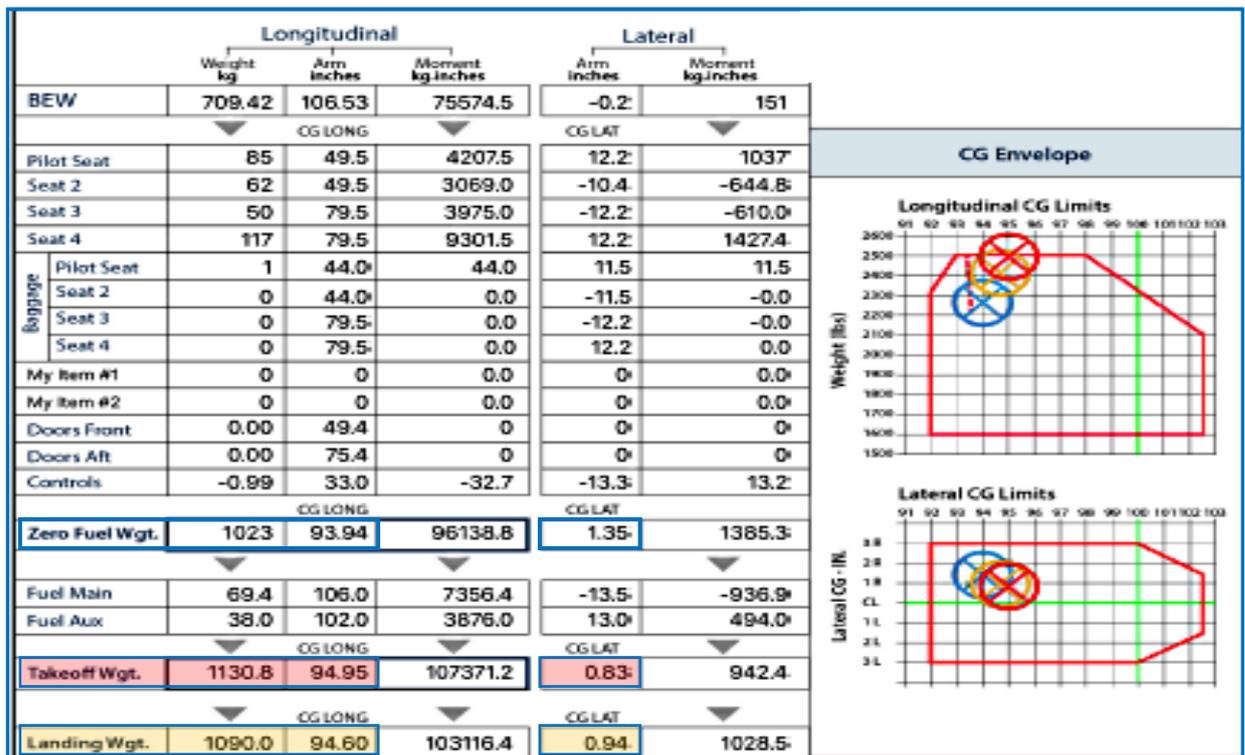
Figure 8 Weight & Balance calculation provided by the pilot

The calculation indicates that both on takeoff and on landing, the weight of the helicopter (Takeoff Wgt. ⊗ = 1130,8 kg, Landing Wgt. ⊗ = 1090,0kg) was within limits (Maximum Gross Weight = 1134 kg).

The longitudinal and lateral Center of Gravity (CG) of the helicopter also remained within limits during the flight. The lateral CG was slightly to the right of the helicopter's centerline.

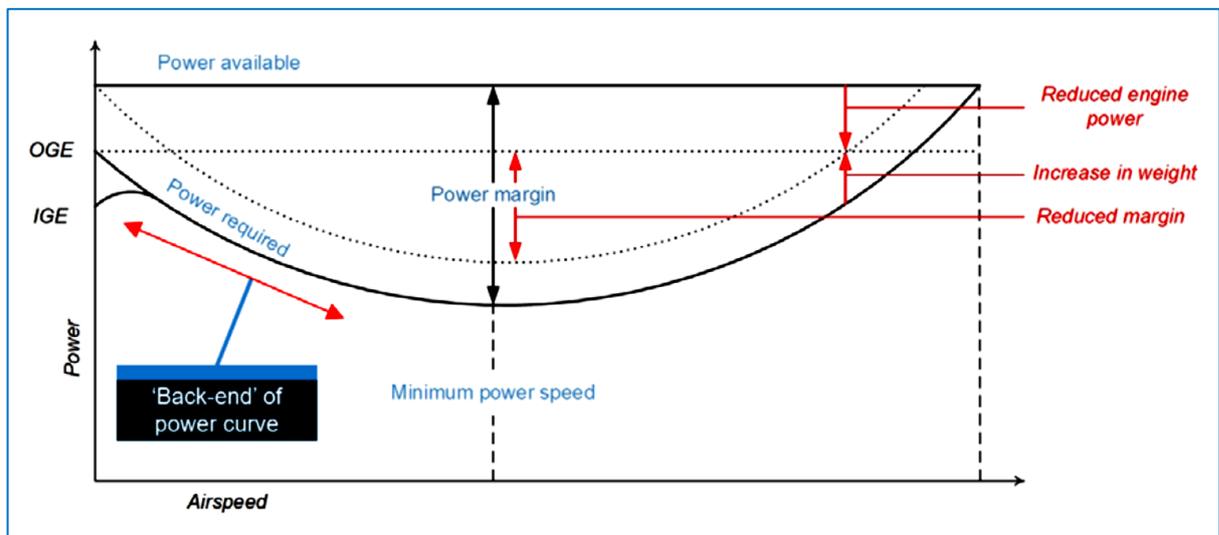
Figure 17 Typical power curve of a helicopter (source: ATSB)

In addition, the helicopter gradually lost its forward airspeed during descent and did not maintain the speed that requires the least power, the 'minimum power speed'. When the helicopter slowed down below minimum power speed, it moved towards the 'back-end' of the power curve, making the rotor less efficient (see fig. 17). Therefore, at lower air speeds, the helicopter needed more rotor thrust to maintain altitude.
