Safety Investigation Report

Ref. AAIU-2011-21

Abstract

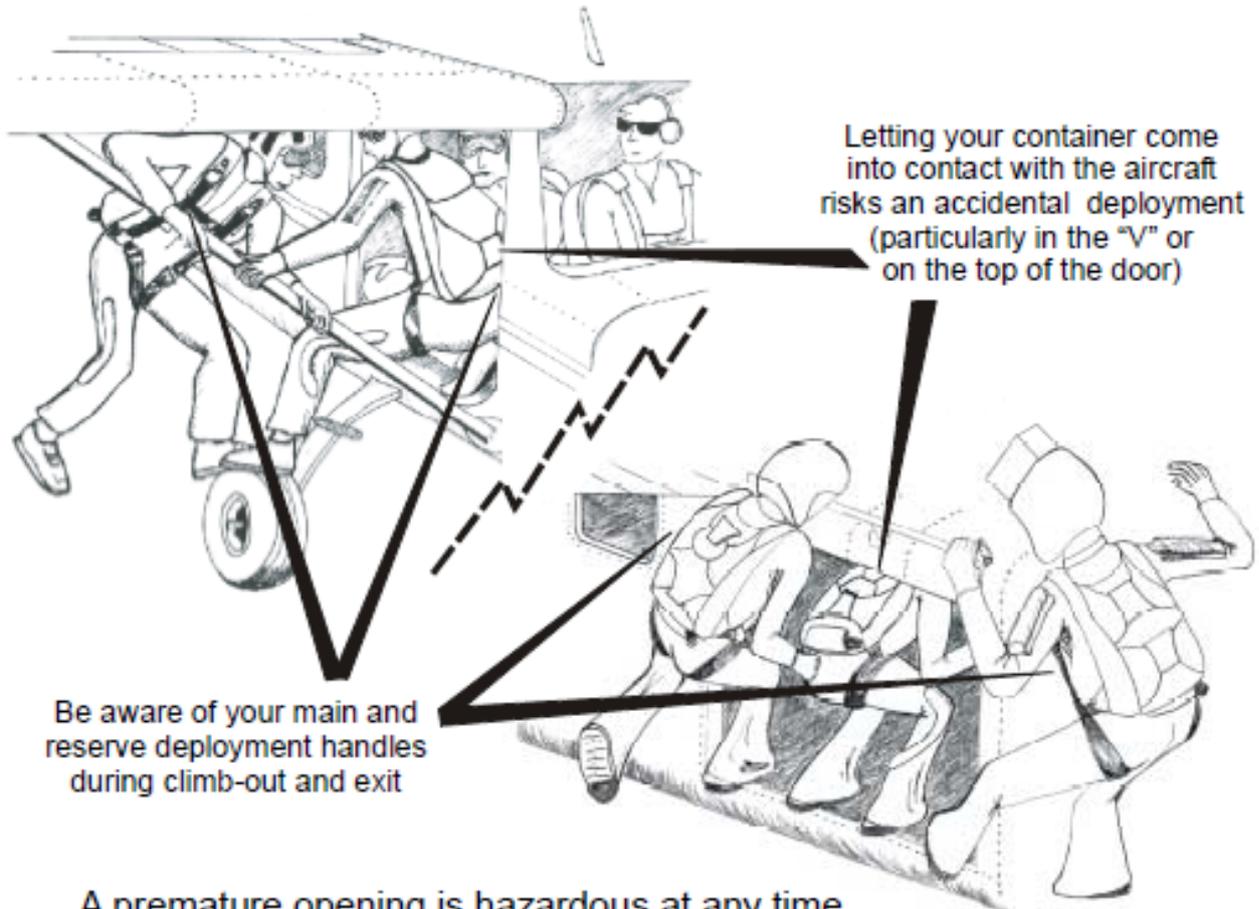
A PREMATURE OPENING CAN PROVE FATAL

Letting your container come into contact with the aircraft risks an accidental deployment (particularly in the "V" or on the top of the door)

A premature opening is hazardous at any time. It can be extremely hazardous if it occurs with an open door or during exit. The result can be major aircraft damage and serious, if not fatal, injury to the jumper.

Be aware of your main and reserve deployment handles during climb-out and exit
