Air Accident Investigation Unit

**FINAL REPORT ON THE ACCIDENT
OCCURRED ON 12/08/2006
AT KEIHEUVEL
ON A FOKKER S-11 REGISTERED
PH-HTC**

Ref. AAIU-2006-01
Issue date: 18 October 2007
Status: Final

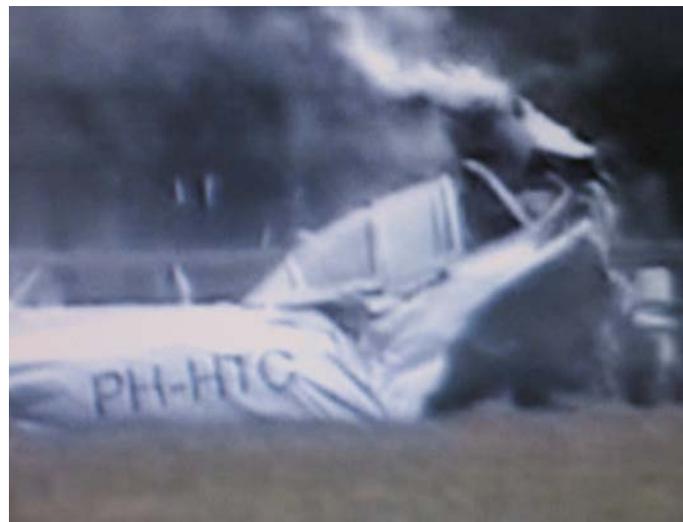
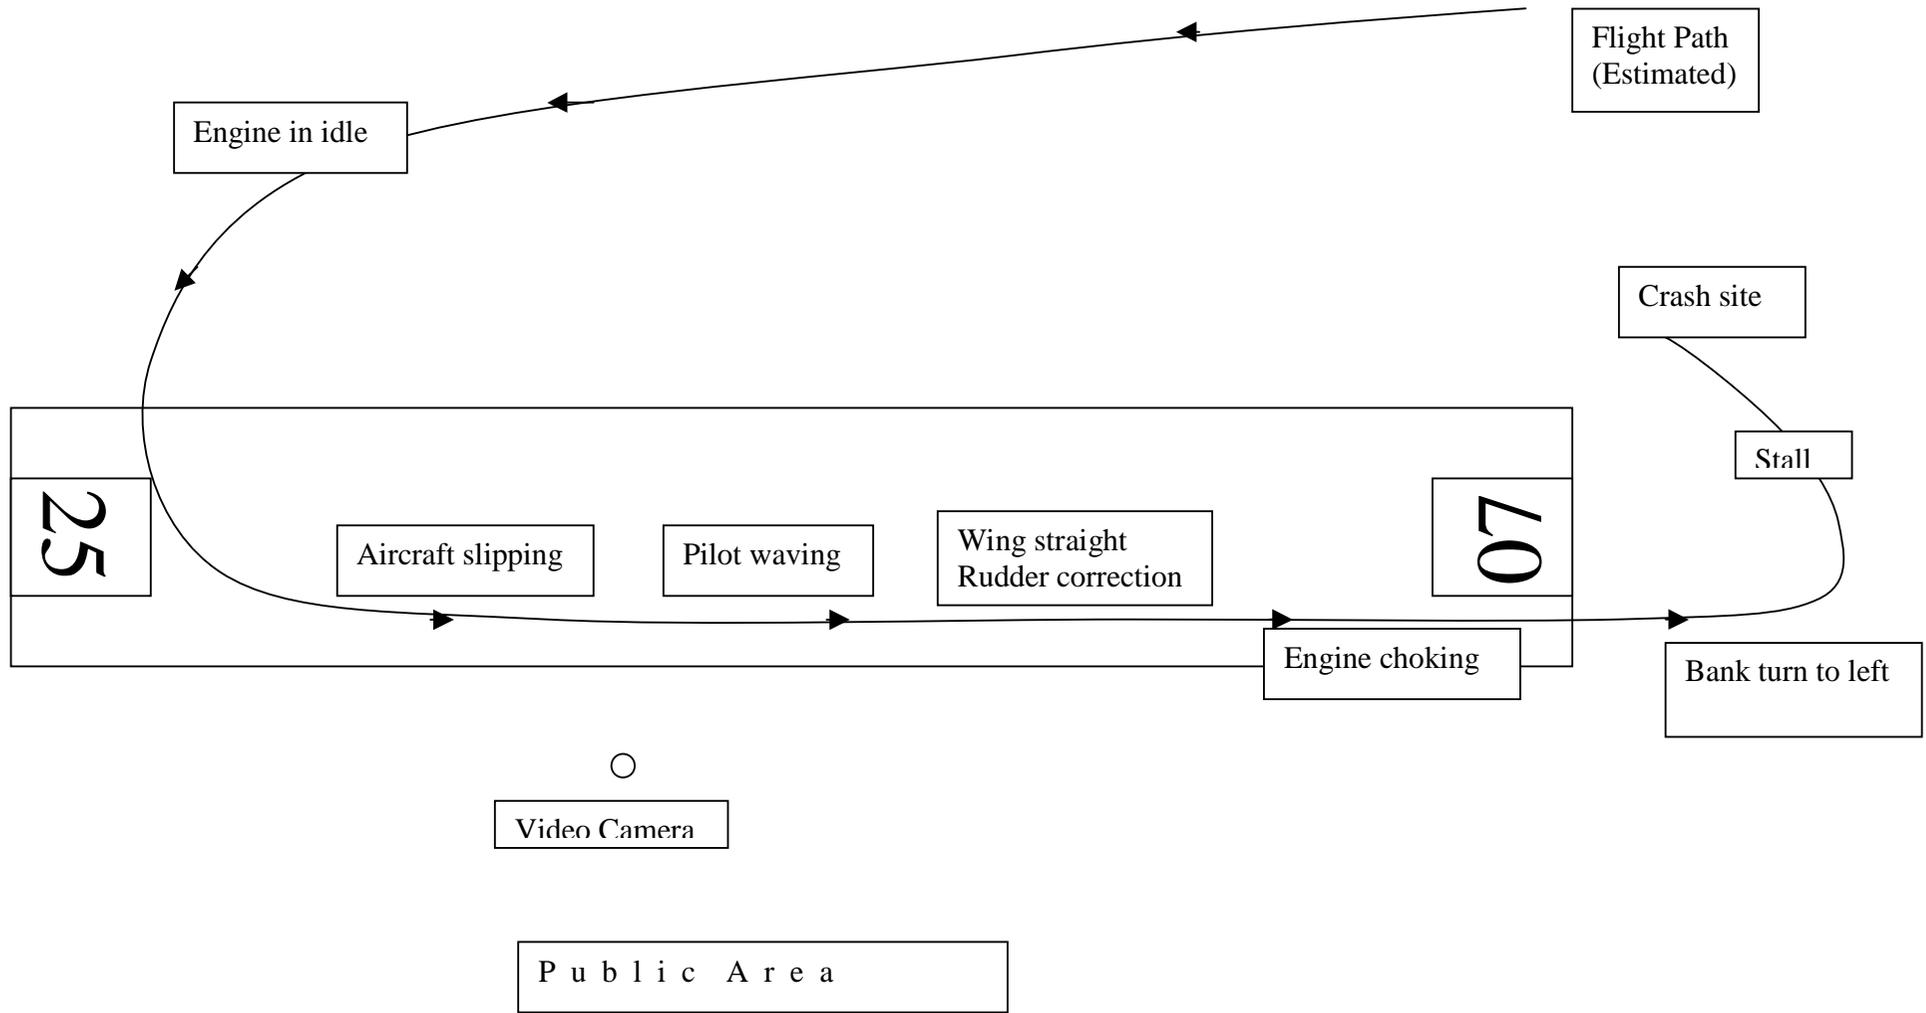
Crash

The propeller broke on impact, and the two blades, severed at the hub, were found separated by a distance of ca 10 meters, indicating that the engine was not delivering high power upon impact.

The pilot was sitting on the left seat, but due to the force of the impact, was found between the 2 seats.

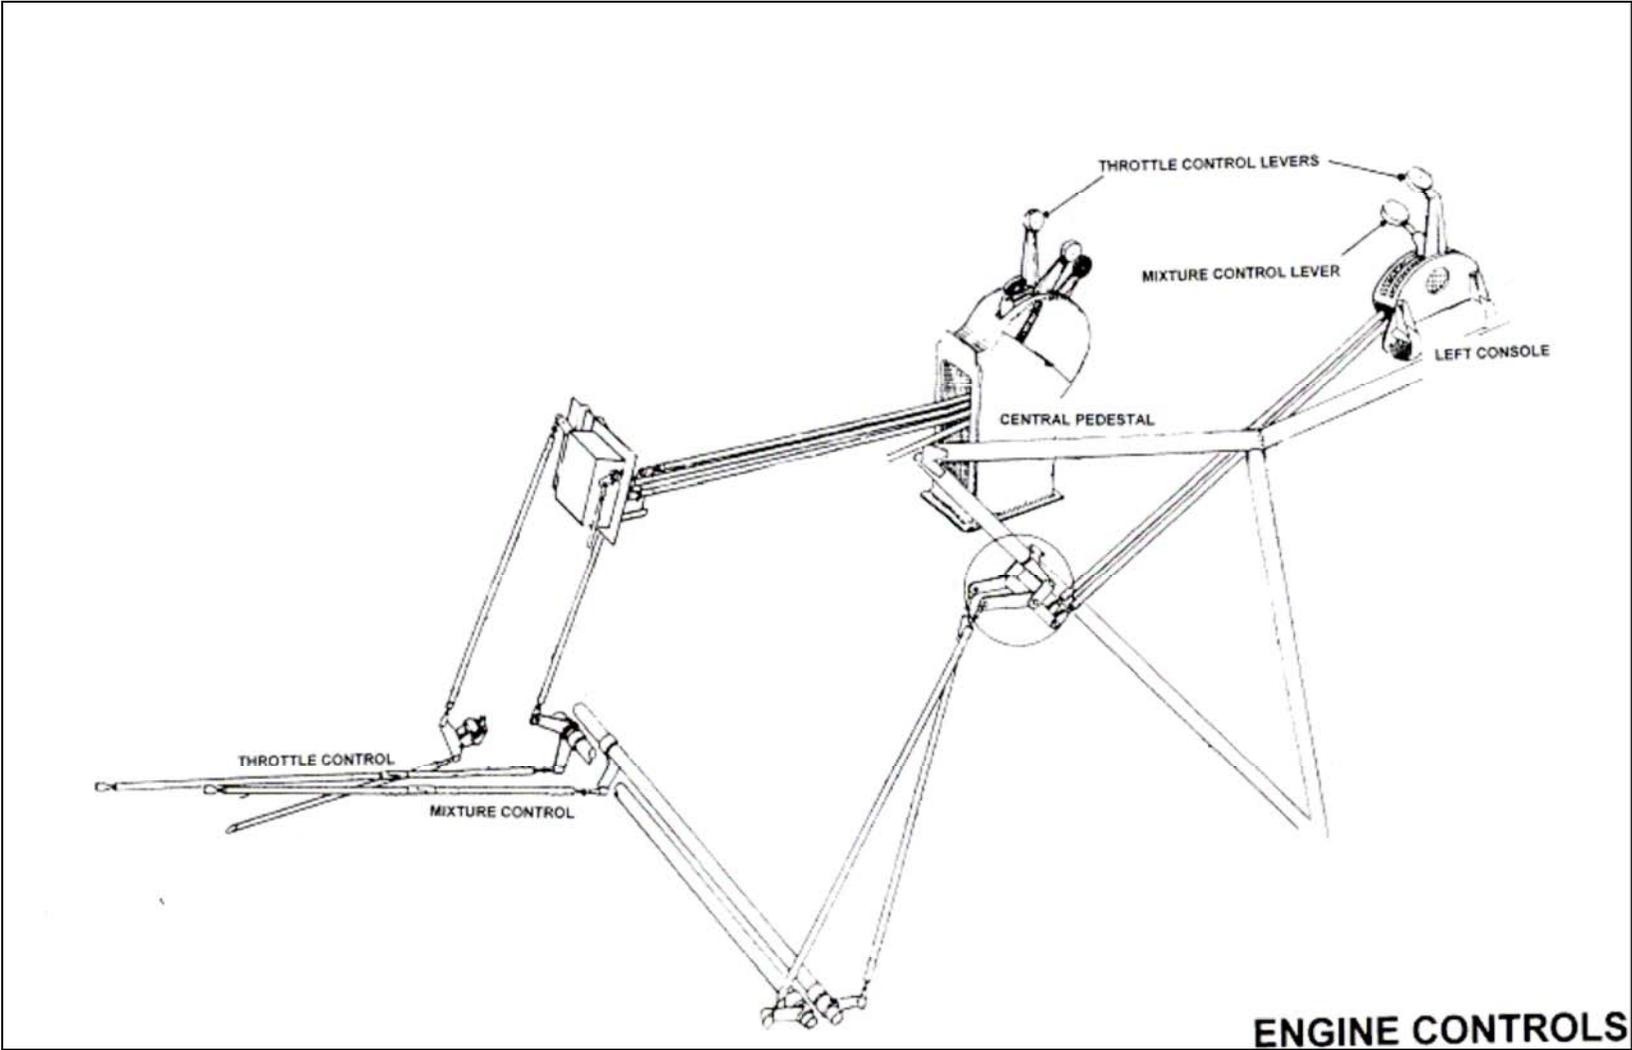
Position of the control unit, as found in the wreckage.

The throttle control lever and the mixture control lever were both found forward in the wreckage of PH-HTC.

The Fuel mixture valve inside the carburettor was found 2/3 open. There was no other anomalies found in the carburettor. The spark plugs showed a “chocolate” brown colour, signs that the mixture air/fuel was correct.

The fact that the Control lever was found in a forward position doesn't give an absolute certainty that it reflects the actual position of the lever, as set by the pilot.

The connection between the control lever in the cockpit and the command lever on the engine is made through rigid rods. The control rods, attached to the control lever, showed evidences of buckling; thus compression, that would – normally- push the control lever to the 'rich' position.

However, the impact of the aircraft with the ground caused initially a crushing of the structure and this movement of the engine (towards the rear) may have resulted in a forward movement of the mixture control lever.
