**Air Accident Investigation Unit**

# **FINAL REPORT ON THE ACCIDENT TO GRUMMAN AA-1-B (OO-PMS) IN CHARLEROI ON JULY 28,2007**

**Ref. AAIU-2007-11**

**Issue date: 24 January 2008**

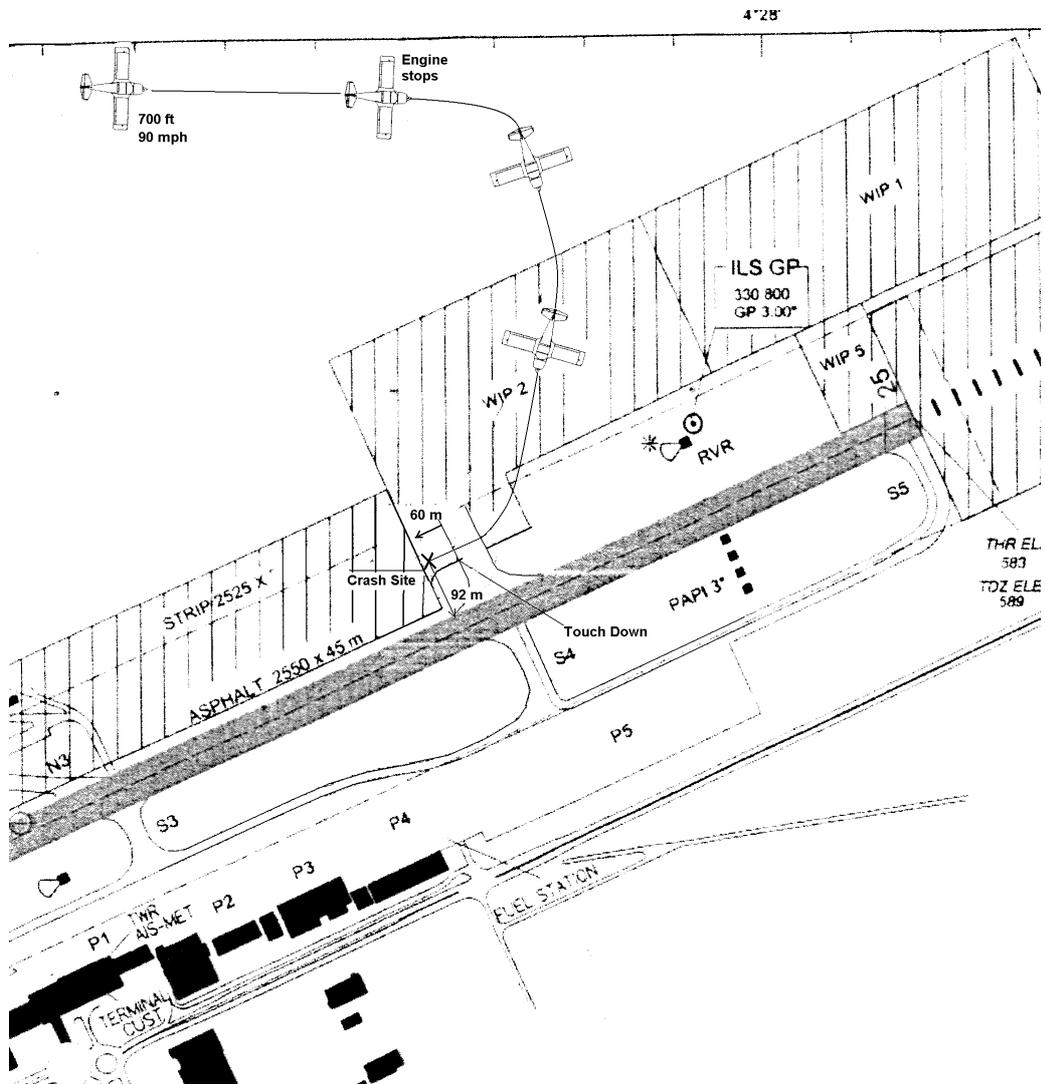
Before reaching the Whisky check-point (the water tower of Caterpillar on the N5 road Brussels-Charleroi), the pilot prepared for landing. At that time, the engine started coughing; the pilot changed the power rating, and the sputtering stopped. A few minutes later, above the Whisky check-point, the engine coughed again; the pilot switched off the fuel pump, and the problem seemed settled. During these events, the aircraft was losing altitude, in order to maintain speed; the altitude upon reaching EBCI airport was around 700ft.

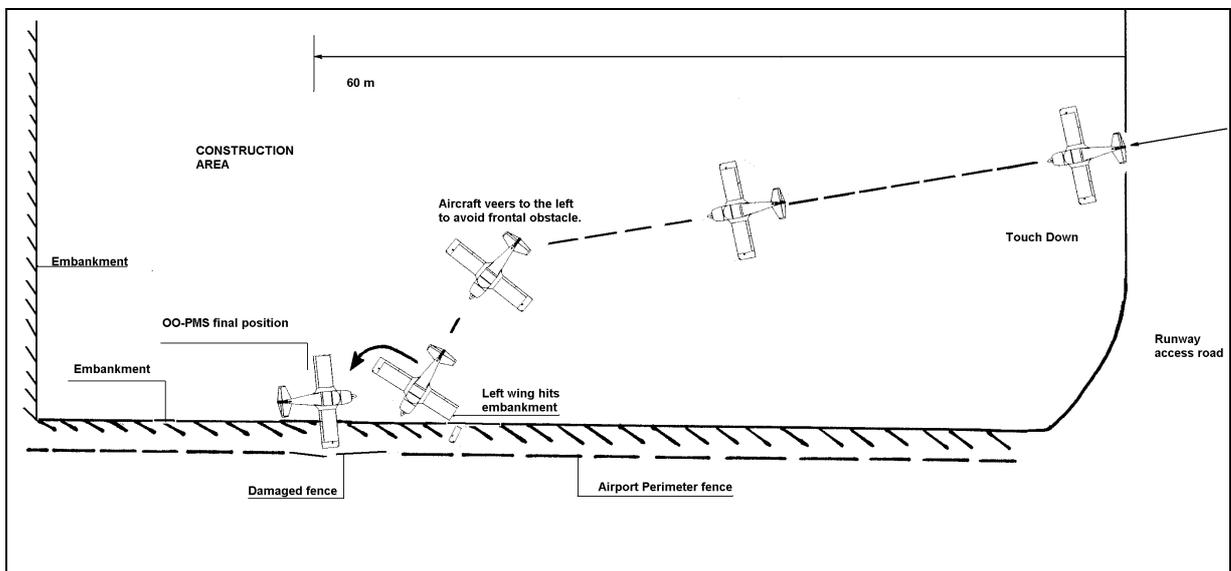
The engine stopped when the aircraft reached the airport zone. The pilot wanted to land the aircraft as soon as possible, and directed the aircraft in a glide dive in the direction of the airport tower. The aircraft never reached the runway, and landed on a construction zone outside the perimeter of the airport. The aircraft touched the ground parallel to the runway, rolled for 60m, then veered towards the embankment slope bordering the airport perimeter.

When impacting the embankment, the left wing contacted the perimeter fence, and the aircraft rotated 180°.  
 The aircraft stopped at 92m from the Runway 25.

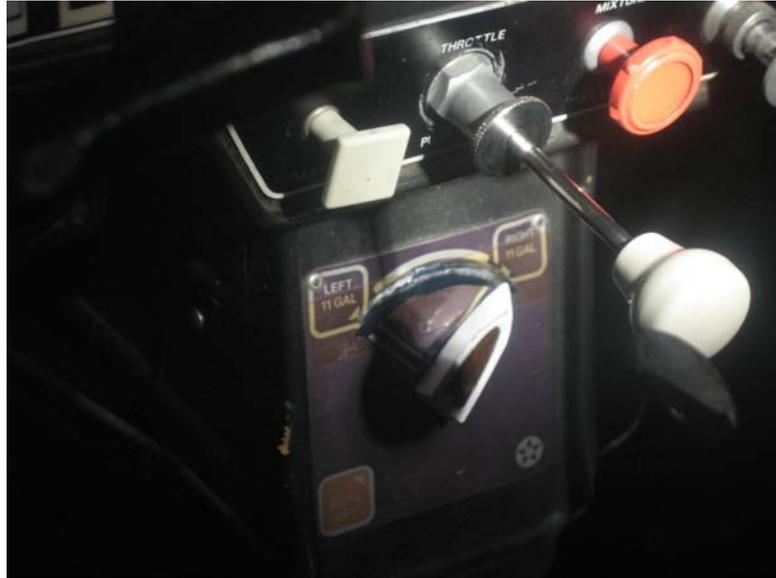
The tubular main wing spar is also a two-cell fuel tank. Each tank holds 12 USG, of which 11 are usable.

The 22 usable USG are selected by an OFF-LEFT-RIGHT selector.

**To maintain best fuel load balance, change fuel selector at approximately 30-minute intervals during cruise. If flying solo, maintain the left tank about 1/2-tank lower than the right. This technique will substantially improve lateral trim**
