Safety Investigation Report

Ref. AAIU-2020-01-31-01
Issue date: 19 November 2021
Status: Final

Classification:	Incident	Occurrence category:	SCF-NP
Level of investigation:	Standard	Type of operation:	Non-commercial other-than- complex - NCO
Date and time¹:	31 January 2020 11:30	Phase:	Initial climb
Location:	51,235624°N 04,437490°E	Operator:	Arendair Ltd
Aircraft:	Partenavia P68B	Aircraft damage:	Minor
Aircraft category:	Fixed wing - Small aeroplane (MTOW <5700kg)	Injuries:	None

During a local flight after maintenance, when the aircraft was climbing at 1000 ft, the emergency door fell out. The door landed at short distance of a car.

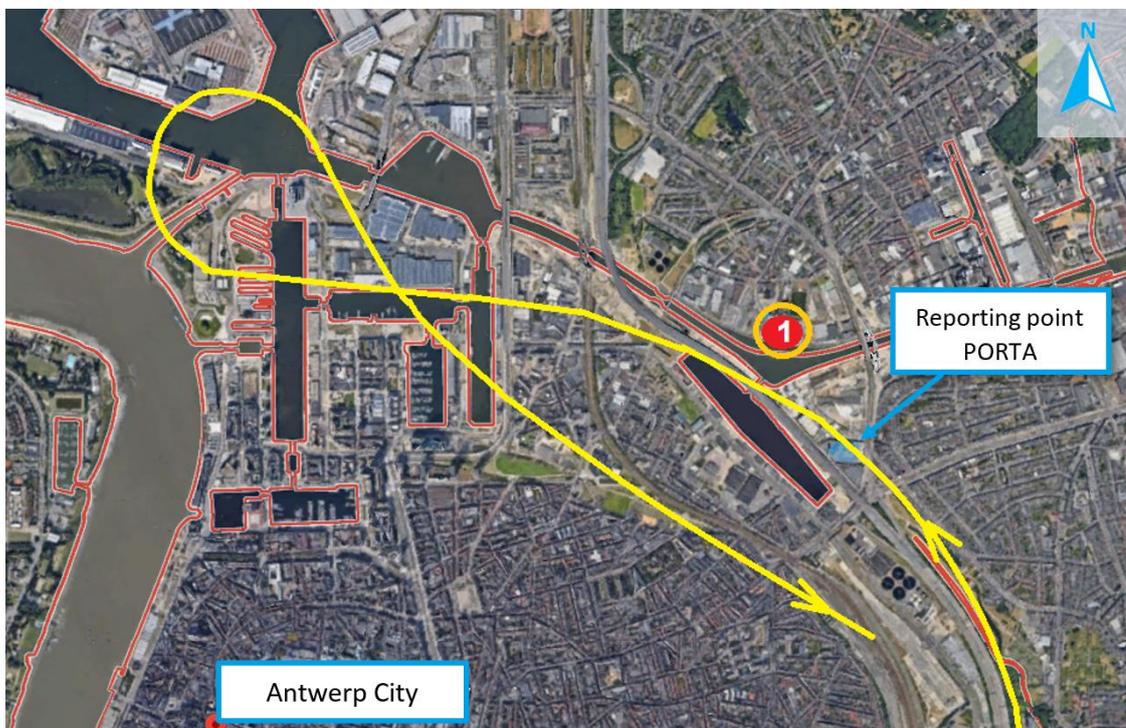
The falling part was spotted by a woman and her son, driving around in the neighborhood. The son noticed a plane flying over, when he suddenly saw that an object fell from the plane. This object landed +/- 15m from the vehicle next to the road on a piece of wasteland (position 1 on Figure 1).

Figure 1: Flight track and position (1) of the part (© Google Earth - 2019)
