# Safety Investigation Report

Ref. AAIU-2017-14

<b>Classification:</b>	Accident	<b>Type of operation:</b>	Specialized Operations – Photography (filming)
<b>Level of investigation:</b>	Standard	<b>Phase:</b>	Taxi
<b>Date and time:</b>	31 March 2017 at 17:00 UTC	<b>Operator:</b>	Heli Service Belgium
<b>Location:</b>	Heliport Sint-Pieters- Leeuw - EBSW	<b>Persons on board:</b>	1
<b>Aircraft:</b>	Eurocopter AS355F2 msn 5187	<b>Aircraft damage:</b>	Substantially
<b>Occurrence category:</b>	Ground collision	<b>Injuries:</b>	None

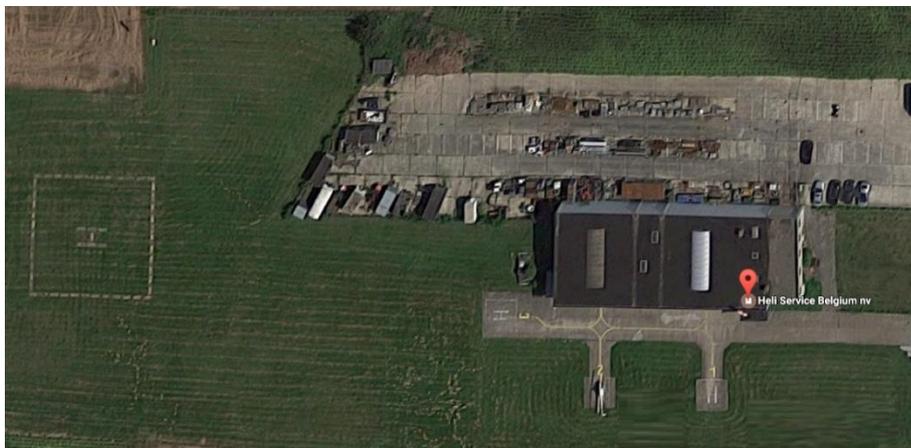
Figure 5: aerial view of the heliport (source: Google Earth)

However the handbook does not describe procedure related to the taxi of helicopters from the FATO to the parking area.

An old (1999) drawing defines the taxiway from the FATO to the helicopter stand places 1, 2 and 3.

It is recommended that HSB reviews the Heliport handbook and the configuration of the existing helicopter parking area in order to:

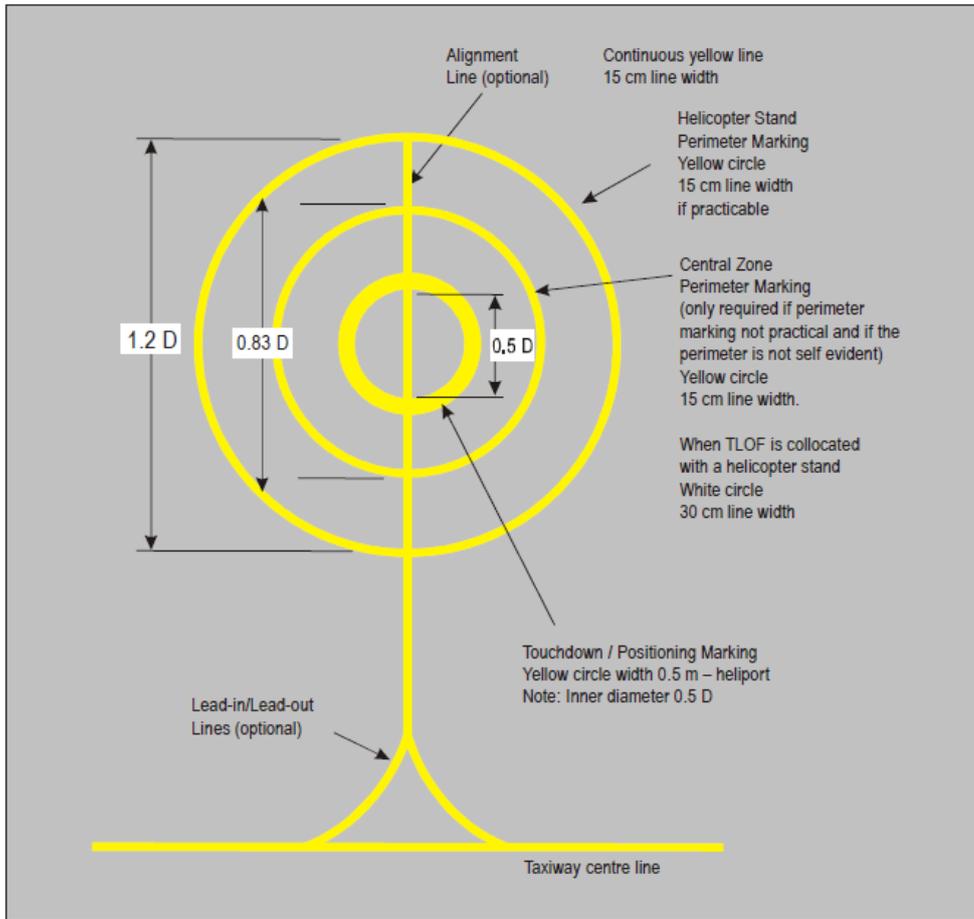
**Figure 8: helicopter stand markings and dimensions**

5.2.17.4 A helicopter stand perimeter marking on a helicopter stand designed for turning or, a central zone perimeter marking, shall be concentric with the central zone of the stand.

5.2.17.6 Alignment lines and lead-in/lead-out lines shall be located as shown in Figure
