Safety Investigation Report

Ref. AAIU-2011-ULM-10
Issue date: 01 October 2018
Status: Final

Classification:	Accident	Occurrence category:	Fuel starvation
Level of investigation:	Desk	Type of operation:	Non-commercial – Ultralight - Training
Date and time:	24 September 2011 at 17:15 UTC	Phase:	Cruise
Location:	In a field located between two streets Kluisstraat and Beugelstraat, at Zottegem. 24.6 km NE of EBAM	Aircraft damage:	Visible limited damage on engine, NLG, wing and rudder. Airplane was written off.
Aircraft:	AirLony Skylane msn: 31	Operator:	Private
Departure airport:	Aerodrome of Amougies (EBAM)	Persons on board:	2
Destination airport	EBAM	Injuries:	None

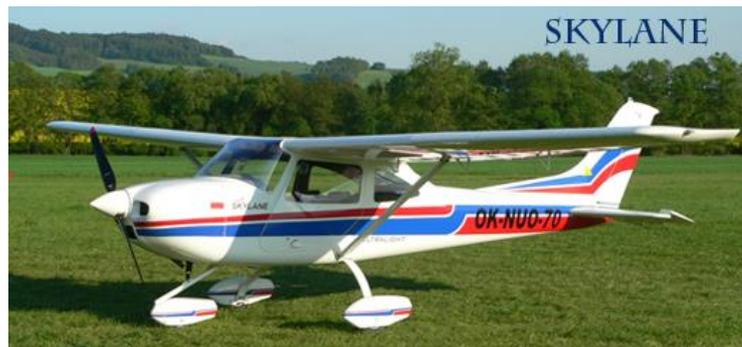
Figure 2

Fuel system

The accident is caused by fuel starvation, due to the unreliability of the fuel quantity indicators.

- Inform the manufacturer of the AirLony Skylane UL about the event and the suspected cause, being the unreliability of the fuel quantity indicators.
- Perform the calibration of the fuel quantity indicator on each of his aircraft and all aircraft being imported in Belgium, involving;
 - Determination of the unusable fuel quantity by running the engine on the ground until it stops, making the fuel level by a red line and adequately shading the area below.
 - Graduating the indicator by a line for each addition of 5 liters fuel in the tank.
- Revise the flight manual to outline the meaning of the added graduation on the indicators. A note will be include to stress the importance of the red line.
- Issue a bulletin to inform all other Belgian owners of AirLony Skylane about the procedure to follow in order to calibrate the fuel quantity indicator.
